SPX SIGNIFICANT EVENTS AND WHETHER IT WOULD HAVE HAPPENED ON EFR

L. RAHMANI
EDR, Centre Lyonnais d'Ingenierie

C. BANDINI
Framatome-Novatome, Lyon

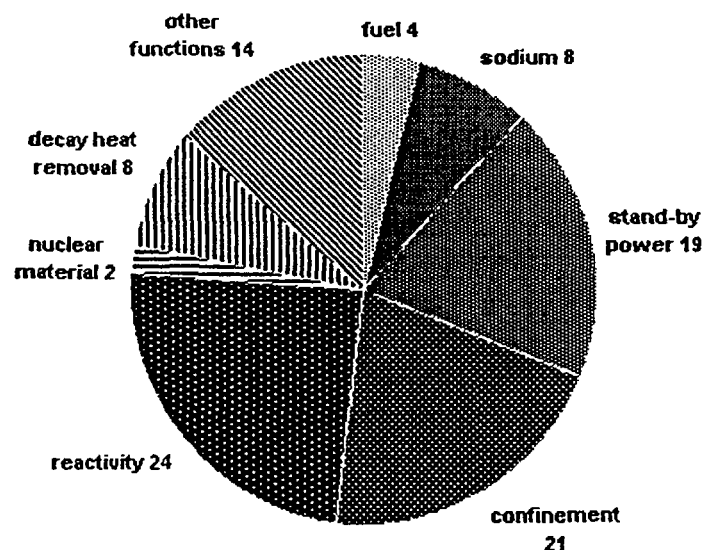
The events are here classified according whether they concern the fuel, radioactivity control, residual heat evacuation, emergency electricity supplies, confinement, control of nuclear material or other functions. In this paper we will first of all examine only the functions involved even if the event does not indicate any deterioration of this function.

We observe that almost two thirds of the anomalies involve the reactivity control function (command of control rod positions), the containment (notably dome isolation and reactor building ventilation) and standby supplies (diesel generator sets, batteries and switchboards that they supply). The anomalies concerning sodium only involve eight events

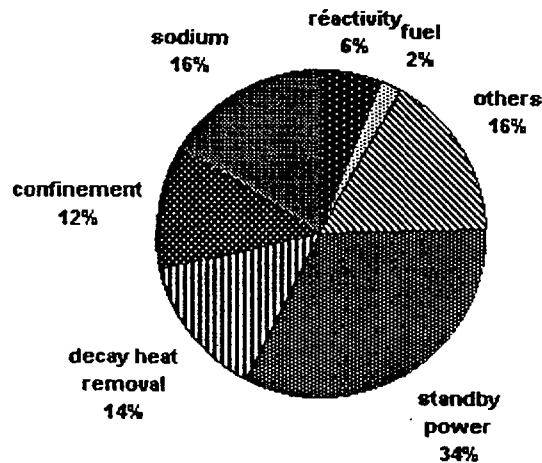
3.2 Impaired functions

If we exclude a half (51) of events which have not led to a deterioration (real or potential) of a reactor safety function, it becomes obvious that the largest number of really significant anomalies is, like on other installations, associated with the loss of standby electricity supply (which did not have important consequences for Superphenix since there are 4 identical sets), but also that the second cause of safety function deterioration is linked to sodium. This illustrates that the two, sodium-related, incidents which were classified level 2 on the INES scale (nos. 40 and 61) were not isolated events.

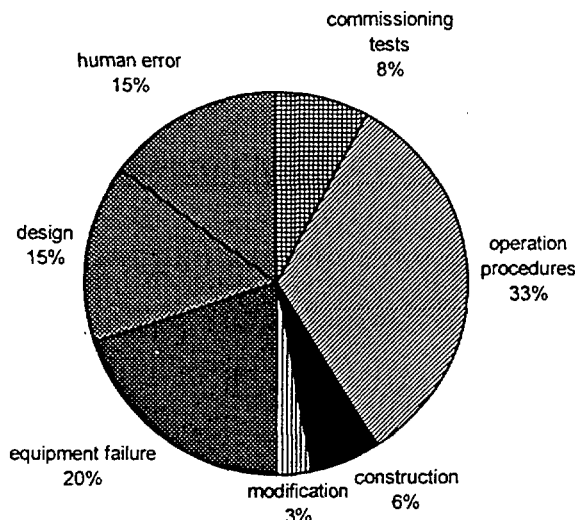
The following graph gives the global percentages, while the table indicates, for each given period, the annual frequency of events.

This classification is partly subjective since in most cases there is not a single cause of the incident. Nevertheless, out of all the events occurring at Creys-Malville, the following trends can be identified:

- Equipment failures and human errors together caused one third of the events. Although precautions (as a matter of quality assurance) can be taken in this respect (selection of equipment, preventive maintenance, training, preparation for works, etc.), these two types of events are nevertheless difficult to avert totally.
