Wildfire Impacts on Power Industry Steel Structures, Part 2

This technical article, in two parts, addresses the adverse impacts of wildfires on power industry steel structures, with an emphasis on the degradation of structural material mechanical properties and protective coating properties due to the high temperature exposure. Part 1 addressed transmission and distribution structures and materials, gases, and corrosive substances generated in wildfires, and high-temperature wildfire effects on bare structural steel mechanical properties.¹ Part 2 addresses high-temperature wildfire effects on galvanized steel coating layers, thermal degradation of organic coatings, concrete mechanical properties, and condition assessment of wildfire exposed structures by non-destructive techniques, including remote temperature monitoring.

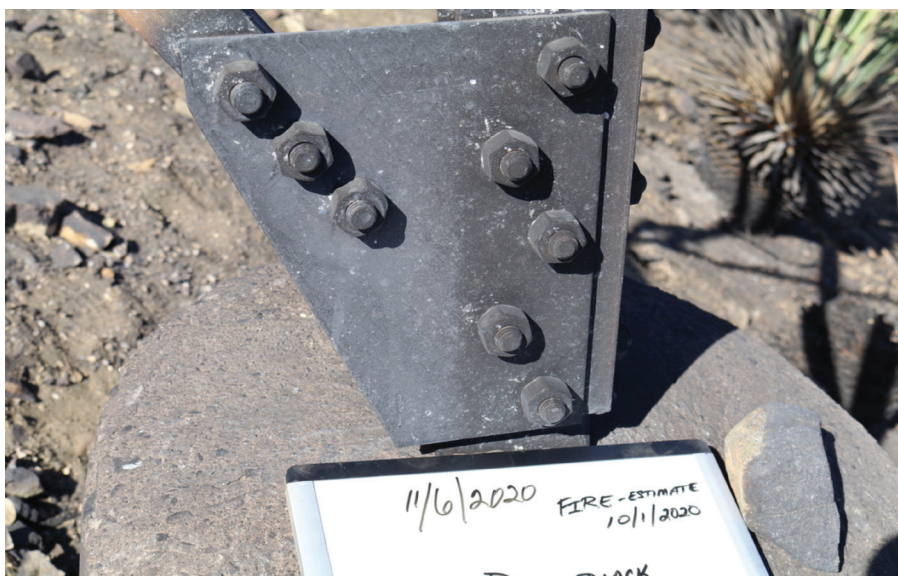
FIGURE 2 A tower leg foundation after exposure to a wildfire. Note spalling of the concrete foundation.

Figure 2 is a photograph of a tower leg foundation that has been exposed to a wildfire. Note that the high temperature of the wildfire has caused spalling of the concrete. If left unmitigated, this could lead to further foundation degradation when exposed to various environmental conditions.

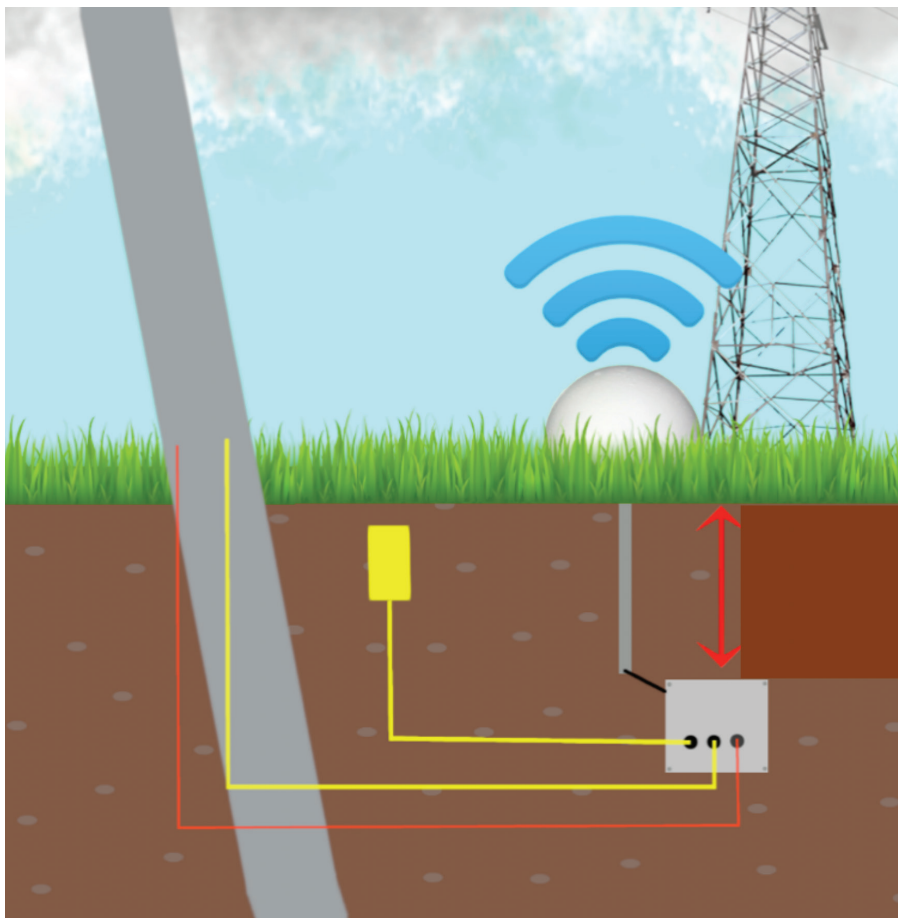
FIGURE 3 Wildfire temperature sensor system configuration for transmission and distribution structures including buried controller unit (gray), temperature sensors (yellow), corrosion sensors (red), and a helical satellite antenna with heat-resistant dome (at ground level).

A wildfire temperature sensor should be able to transmit by satellite the temperature and corrosion potential in real time prior to, during, and after a wildfire. This will provide important information and identify specific towers that have been exposed to wildfire and quantify the risk by transmitting exposure temperature, time of exposure, and corrosion potential. Figure 3

presents one such wildfire temperature sensor system configuration known as EnviroZense,[†] which is a wireless, heat-resistant temperature and corrosion monitoring sensor that is contained in an electrical enclosure underground at the project site. The unit is simple to install and comprises corrosion and temperature sensors—one to monitor the wildfire temperatures and the second to monitor the corrosion activity of the bare steel structure below ground. The monitoring unit is configured to collect data routinely, at specific time intervals. The data are wirelessly transmitted by a satellite module for analysis and warns the project owner of abnormal temperature rises before more serious structural problems occur. The web view allows one to monitor the temperature and corro-
