**ASSESSING STRUCTURAL VULNERABILITIES: ANALYZING THE EFFECTS OF WILDFIRES ON POWER INDUSTRY STEEL INFRASTRUCTURE**

Mehrooz Zamanzadeh, George T. Bayer, Anil Kumar Chikkam, Peyman Taheri, Edward Larkin, and Clinton Char  
Matergenics, Inc.  
100 Business Center Drive  
Pittsburgh, PA 15205

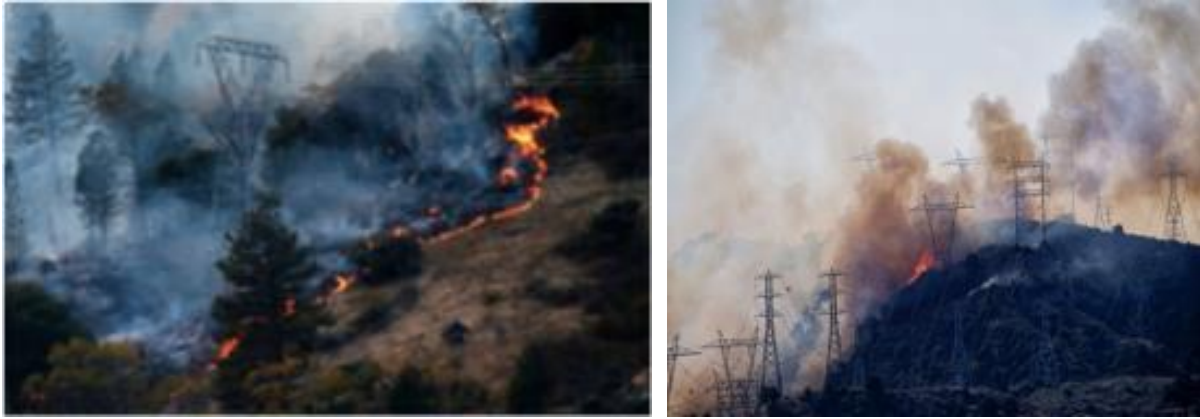
**Figure 3: Photographs of wildfires with heavy soot (particulate matter) content.**

Wildfires are major sources of trace gases and aerosol. It is believed that these emissions significantly influence the chemical composition of the atmosphere and the earth's climate on both regional and global scales.<sup>5</sup> Over the past century, wildfires have accounted for 20 to 25 percent of global carbon emissions. The gaseous pollutants generated by wildfires include greenhouse gases such as carbon dioxide (CO<sub>2</sub>), methane (CH<sub>4</sub>), nitrous oxide (N<sub>2</sub>O) and photochemically reactive compounds such as carbon monoxide (CO), volatile organic carbon (VOC) compounds and nitrogen oxides (NO<sub>x</sub>). Most important to the issue of structural materials corrosion are the fine and coarse particulate matter (PM), or soot, generated by wildfires. Figure 3 presents photographs of wildfires with apparently heavy soot content.

Wildfires produce soot containing chlorides and other water-soluble corrosive ions such as sulfates. The wind will carry the potentially corrosive soot and deposit the soot on galvanized steel and other metallic assets. After the passage of a wildfire, if the structures are not analyzed for contaminants such as chloride and subsequently cleaned free of them, this will cause accelerated corrosion of galvanized steel and weathering steel structures.

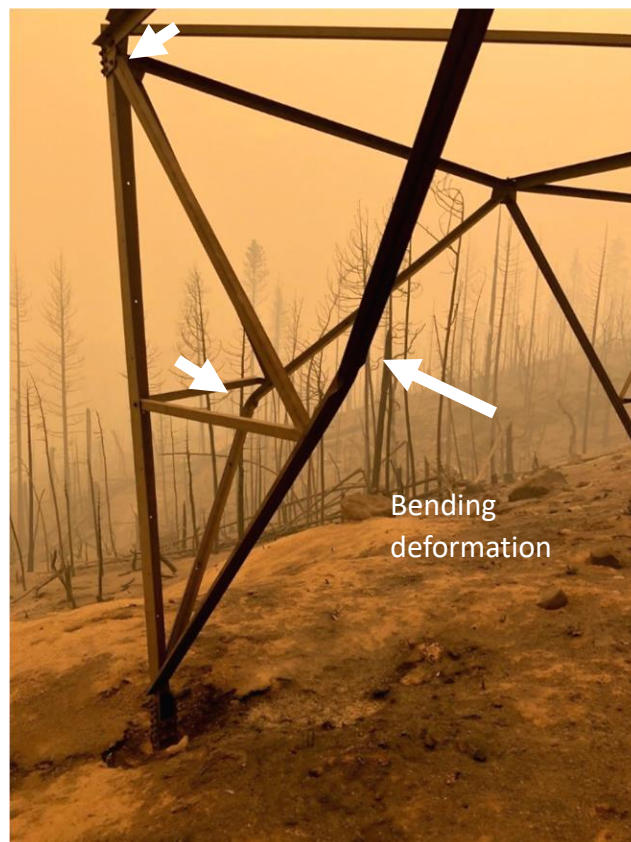
**Figure 4: Photograph showing the deformation of two diagonal steel braces and one instance of a bolted joint pulling away from vertical structural member (upper left). The other arrows point to the inflection points of the deformed diagonals.**

The mechanical properties of steel are temperature dependent. Mechanical properties such as tensile strength, yield strength, ductility, hardness and toughness could be negatively affected when exposed to the heat of a wildfire. A reduction in these properties could reduce the strength capacity of the structure to a level below a minimum factor of safety. Physical properties such as thermal conductivity, electrical conductivity, the coefficient of thermal expansion could also be affected by exposure to a wildfire. In addition, permanent changes in the microstructure of the steel could take place. These are all important factors in considering the effects of wildfires on structural steel.<sup>6,7</sup> Figure 4 illustrates the effect of mechanical deformation on a transmission structure caused by wildfire heating.

Although temperatures in fires can easily exceed 538°C (1000°F), they do not often last for durations which might compromise the integrity of a hot-dip galvanized steel structure.<sup>10</sup> Therefore, the potential for coating damage exists, however, prior experience has typically found minimal fire damage on galvanized structural steel parts exposed to fires. Fire exposure usually results in some orange and/or rust color staining, with a layer of black carbon dust, while the underlying galvanizing is intact. The steel members in Figure 4, exhibit the orange and/or rust color after exposure to a wildfire.

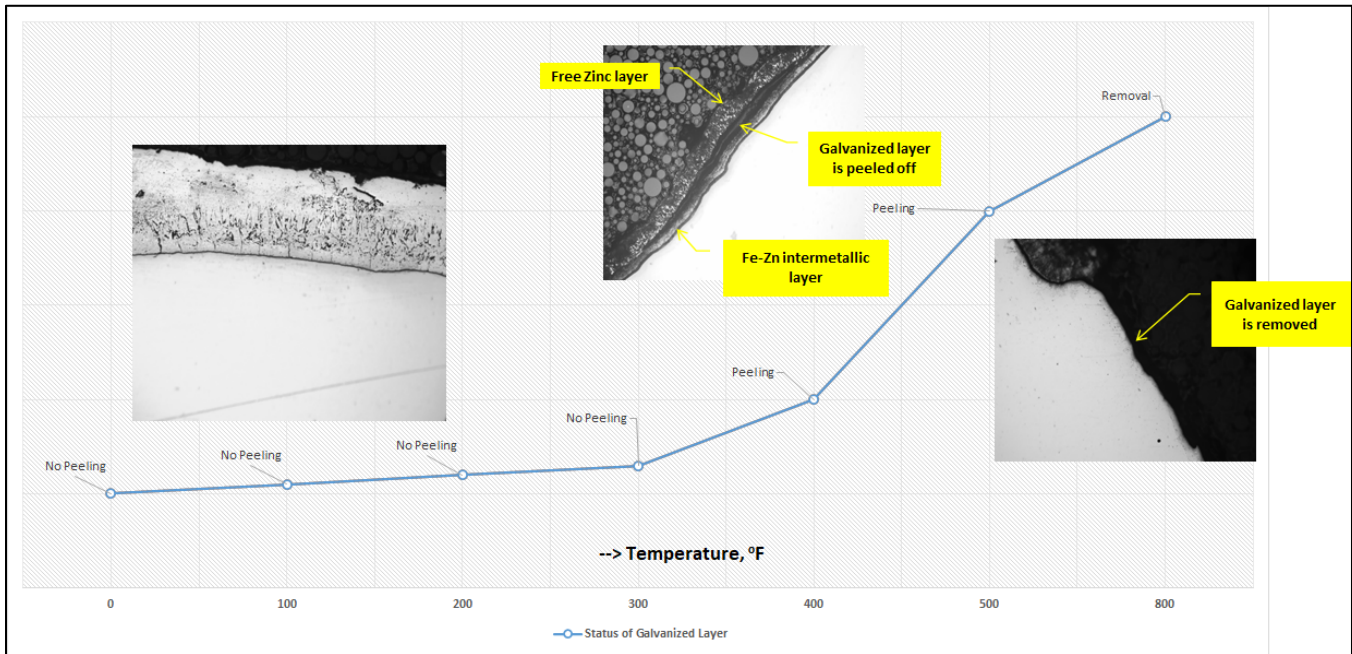
**Figure 6: Cross section microscopic evidence of this peeling phenomenon as documented by the authors.**

Although not often considered, excessive heating of galvanized coating caused by wildfires and other heat sources may induce peeling of the outer free zinc layer, which is caused by metallurgical changes that create a series of closely spaced voids at the free zinc – zinc-iron alloy interface.<sup>9</sup> These voids are produced by the diffusion of zinc from the outer free zinc layer into the inner zinc-iron alloy layer. When these voids expand and form a gap, it causes the outer free zinc layer to physically separate from the

underlying zinc-iron alloy layers. This solid-state physical process is known in metallurgy and materials science as the Kirkendall effect. At or below the industry-recommended limiting service temperature of 200°C (390°F), the coating resists zinc layer peeling.

Figure 6 presents cross section microscopic evidence of this peeling phenomenon as documented by the authors.

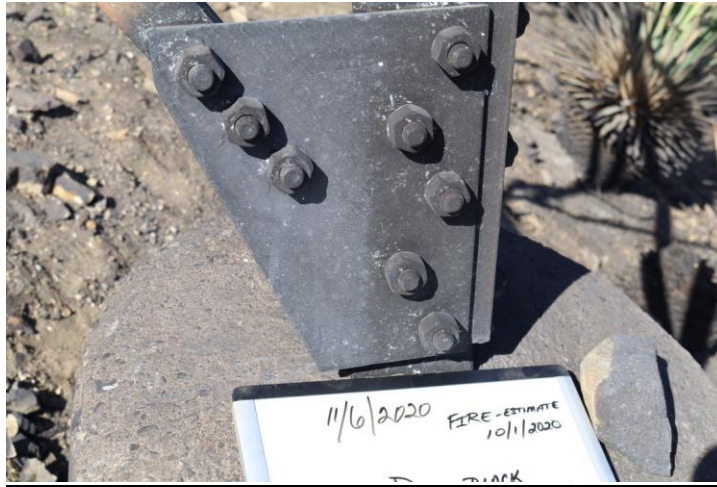
**Figure 7: Photograph of a tower leg foundation after exposure to a wildfire. Note spalling of the concrete foundation.**

Figure 7 is a photograph of a tower leg foundation which has been exposed to wildfire. Note that the high temperature of the wildfire has caused spalling of the concrete. If left unmitigated, this could lead to further foundation degradation when exposed to the various environmental conditions.

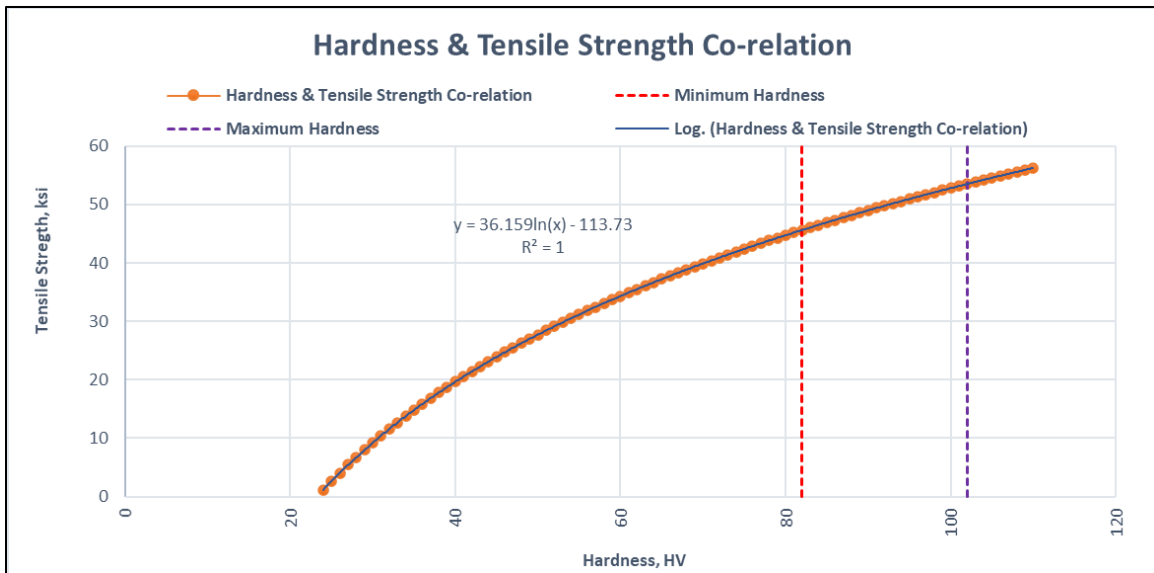
**Figure 8: Hardness and tensile strength correlation between Vickers (HV) microhardness and tensile strength (KSI).**

As the heat from a wildfire can affect the tensile strength of steel it is recommended that on-site hardness testing be performed using portable hardness testing equipment. Some models of portable hardness testers can convert measured values directly to approximate tensile strengths. If not, measured hardness values can be converted to Brinell hardness using the hardness conversion tables found in ASTM E140 – 12B(2019)e1.<sup>20</sup> Brinell hardness values have a known correlation with ultimate tensile strength which can then be calculated. Figure 8 shows a hardness and tensile strength correlation between Vickers (HV) microhardness and tensile strength (KSI).
