# Investigation of Impact Performance of Glass/Epoxy Laminates

**Abstract-** The main objective of this paper is to investigate the effect of properties of resin and fibre on the performance of Glass/Epoxy laminates, a fibre-reinforced composites. Compression failure of composite structures previously damaged by an impact event is due to the propagation of impact-induced damage mechanisms such as interlaminar bonding, constituent micro cracking, sub laminate buckling, as well as the interactions between these mechanisms. This requires fabrication of woven glass fibre epoxy matrix laminates with 1% graphite fillers. Fabrication is done by vacuum bag method followed by curing for specified time in hot air oven. The impact test was carried out for a specific height with given mass and diameter of hemispherical shape impactor. The compression loading was given to the impacted specimen. The damage size was analyzed. Ultimate Compressive residual strength was then calculated.

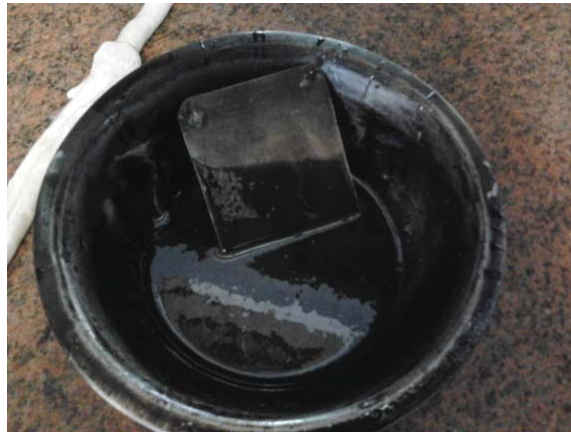
The fibre used here for the material is E-glass which is a plain weave and is bidirectional. Resin used here is epoxy LY 556 and is mixed with hardener HY 951 in the ratio of 1:10 along with graphite fillers which is a fine black powder of about 400 mesh.

Figure 1. Resin mixed with graphite powder

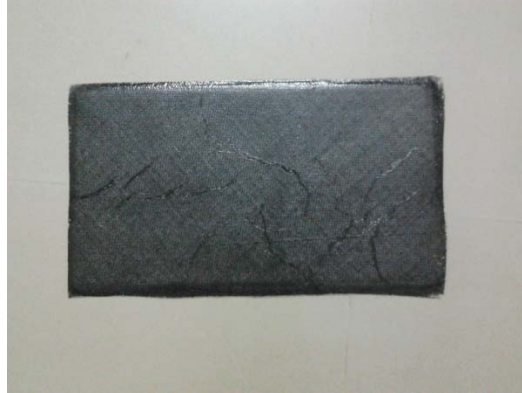
The required specimen dimension is 300×150×3 mm and the fabric is cut accordingly in order to achieve the stacking angle [0/±45/90]<sub>s</sub>. During hand lay-up, each ply is impregnated with epoxy resin mixed with graphite fillers. After laying up, the sealant is covered on all four sides of the laminate and its upper surface with a perforated sheet. Surface mat was spread above it to absorb the excess resin. Vacuum of about 550 Hg/mm<sup>2</sup> was applied through vacuum valve at one corner of the system which helps in air evacuation. The system was allowed for ambient cure for about 20 hours along with the vacuum pressure. The bagged part was then placed in hot air oven which is shown in fig. 2 at 120<sup>o</sup> C for two hours and later allowed to cool at room temperature. The volume fraction of the laminate is shown in table-1 and the final laminate is shown in Figure 2.

Figure 2. Glass-Epoxy laminate with graphite filler

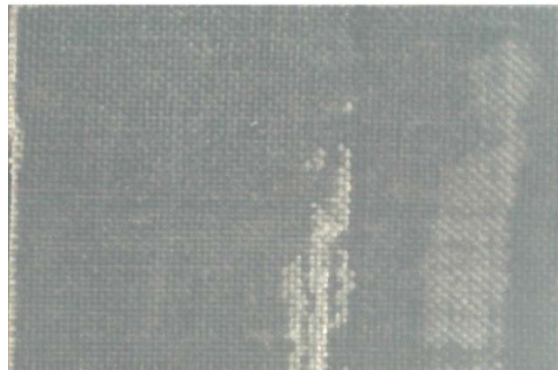
After the laminate subjected to impact force, delamination occurs which was then progressively propagated during the application of compressive force. The impacted specimen is shown in Figure 4 and the compression after impact specimen is shown in Figure 5 & Figure 6

Figure 4. Impact induced damage

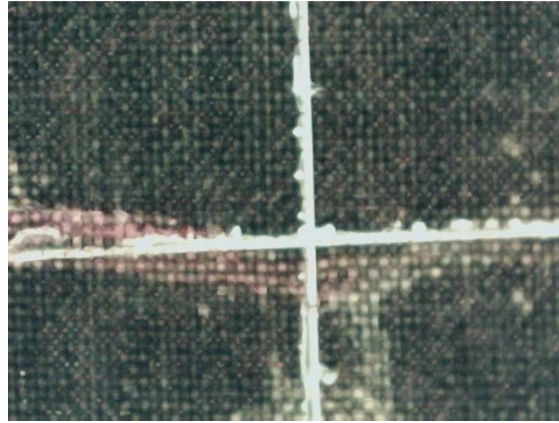
Figure 5. Damage after compression loading viewed from front face

From Figures, it is evident that after impact induced compression, the final failure was controlled by sudden extension of the horizontal crack towards the edges of the specimen. Load-displacement curve of impacted composite laminate in compression is shown in Figure 7.

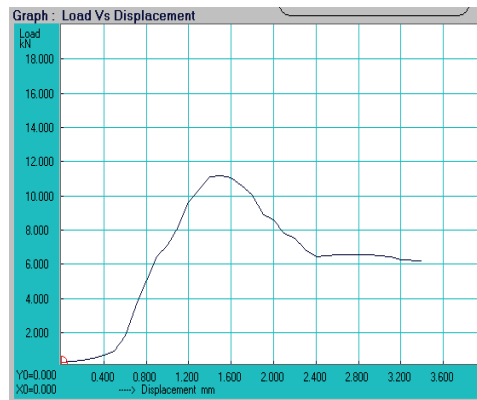
Figure 7. Load-Displacement curve of an impacted composite laminate in compression

From the plot shown in Figure 7, the ultimate compressive residual strength was calculated as below.

$F_{CAI} = 11205 / (100 \times 2.6) = 43 \text{ Mpa}$

Thus, the ultimate compressive residual strength was found to be 43 MPa.

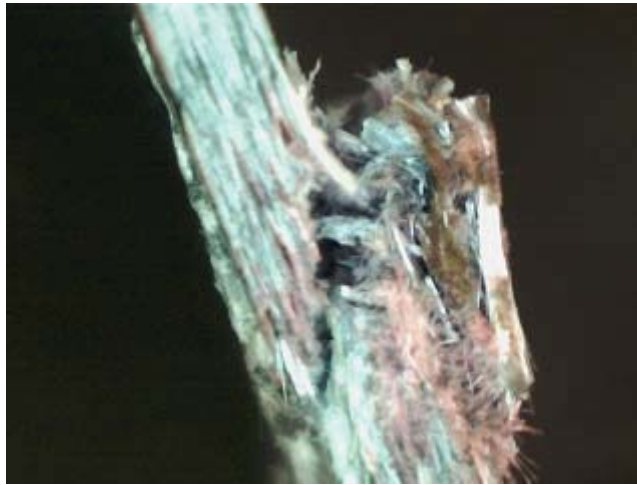
Delamination occurs in the specimen after CAI test is shown in the Figure 8,

Figure 8. Delamination after CAI test
