# PREPARATION AND HANDLING OF SUPERCONDUCTING RF CAVITIES

Takaaki Furuya

KEK, 1-1 Oho, Tsukuba-shi  
Ibaraki-ken, 305 Japan

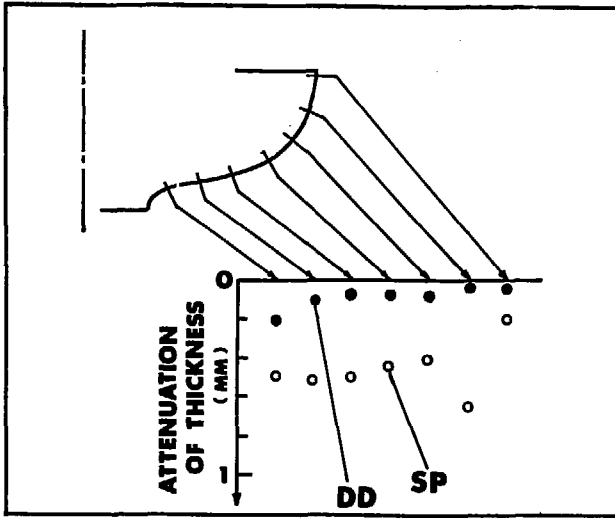
Figure 1: Comparison of the thickness attenuation between deep-drawing(DD) and spinning(SP); large attenuation causes the variety of thickness at the welding planes.

At KEK, DD was tested and compared with SP before making 320 half cells for TRISTAN MR. Because of following advantages for such mass production, DD was selected; less attenuation of thickness (Figure 1), less inclusions, smoother surface and no need of well-trained specialist. On the other hand, larger sheets and better uniformities of both material thickness and mechanical properties are required for DD than those for SP.

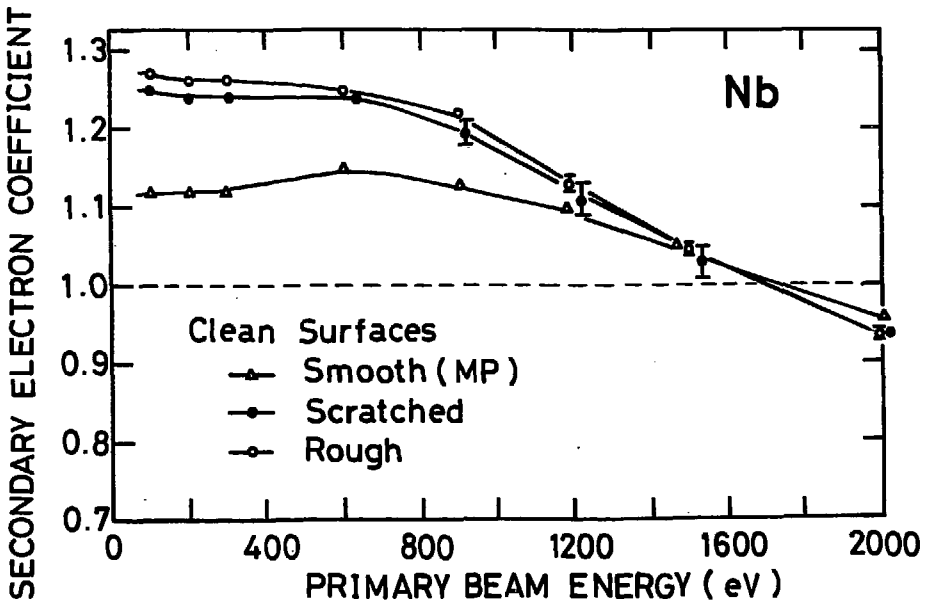
Figure 2: Secondary electron emission coefficient of Nb; mechanically polished(MP), scratched and etched (rough) surface (ref.[10]).

The surface roughness of greater than 0.5  $\mu\text{m}$  and scratches enhance the secondary electron emission coefficient of Nb surface below 1.5 KeV[10] as shown in Figure 2, in which the coefficients of the buffed (MP), scratched and etched (rough) Nb surface are compared. In general, the roughness of chemical polished surface is an order of 1  $\mu\text{m}$ , on the other hand, that of electropolished is 0.2  $\mu\text{m}$ . In this sense, electropolishing has an advantage for the reduction of electron emission, but in the range of Eacc up to 10 MV/m there seems to be little difference of the cavity performance between CP and EP.

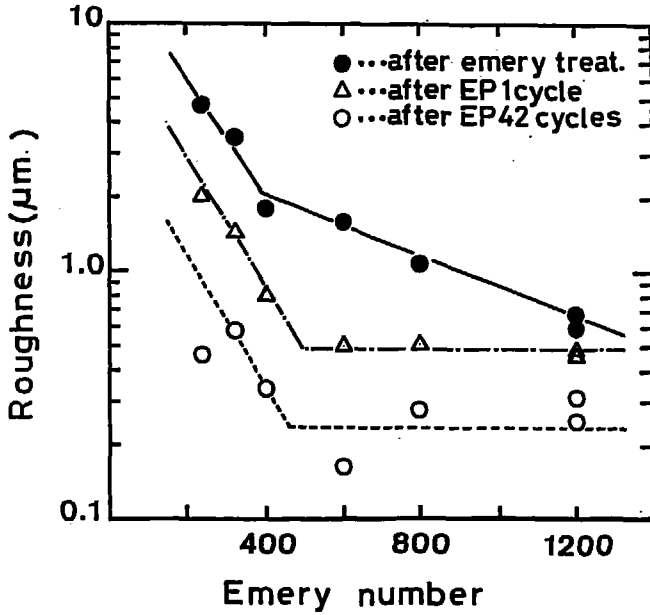
Figure 3: Effect of emery number to the surface roughness; after mechanically finished with various emery papers, and after subsequent electropolishing (1 cycle = 2  $\mu$ m).

At KEK, whole inner surface of the half cells is removed by 30  $\mu\text{m}$  with emery papers #80-800 before electropolishing in order to eliminate the scratches and to obtain smoother surface. The roughness of electropolished surface depends on that of before the polishing as shown in Figure 3, so that before the polishing, the surface should be finished with the emery paper which has the number of more than #800. On the other hand, much pollution with the abrasive material is left on the cavity surface and contaminate the acid mixture used for chemical treatment. This contamination causes a severe problem for the control of the mixture.

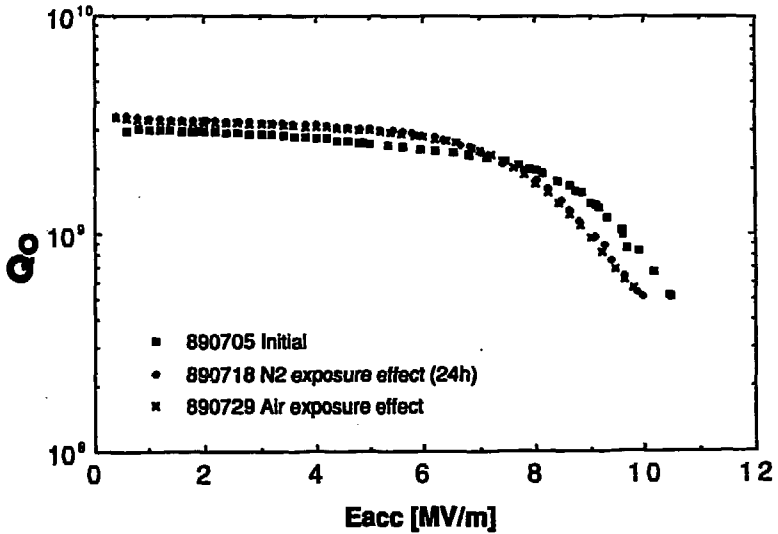
Figure 4: Performance of a single cavity exposed to filtered N<sub>2</sub> and air at KEK.

No degradation of performance up to Eacc of 10 MV/m has been observed by a single cavity at KEK in which the activated surface by RF measurement was

exposed to filtered (>99.9999999 % removal of 0.05  $\mu$ m particles) air and N<sub>2</sub> gas(Figure 4). Similar results has been obtained for clean air at Cornell[18]. These results suggests that pressurizing and counter flowing of pure N<sub>2</sub> gas during the assembly are useful to prevent dust particles from coming into the cavity for not only assembling after a laboratory test but re-assembling after any trouble.

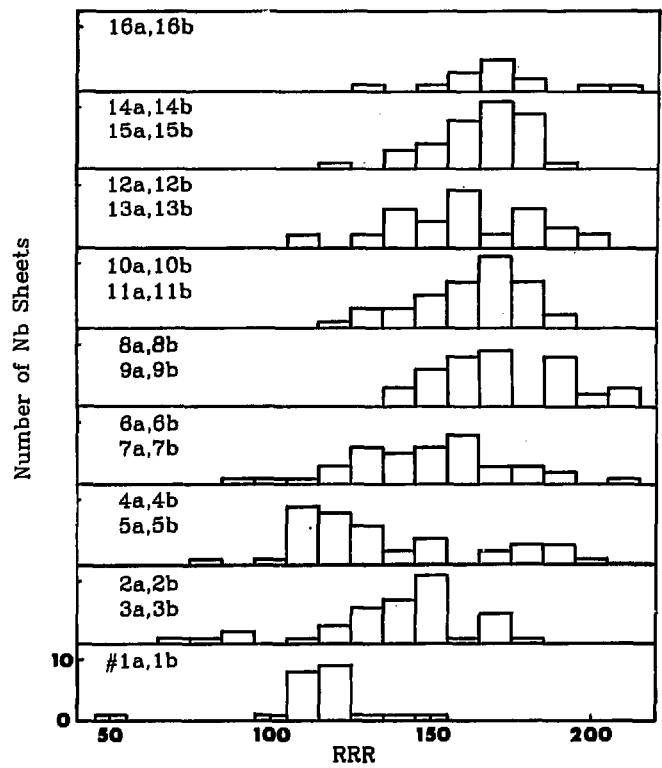
Figure 5: RRR of Nb used for TRISTAN cavities.

For all Nb sheets, the following items are checked; mechanical properties, thickness, surface impurities and RRR. The thickness of each sheet is measured at 57 points, and the sheets which have the inhomogeneity of a thickness of more than 0.2 mm are rejected as long as it can be allowed. Before annealing, all sheets are immersed into a water bath for more than 10h to find rust on the surface. Figure 5 shows the distribution of RRR for all Nb sheets used for TRISTAN cavities.

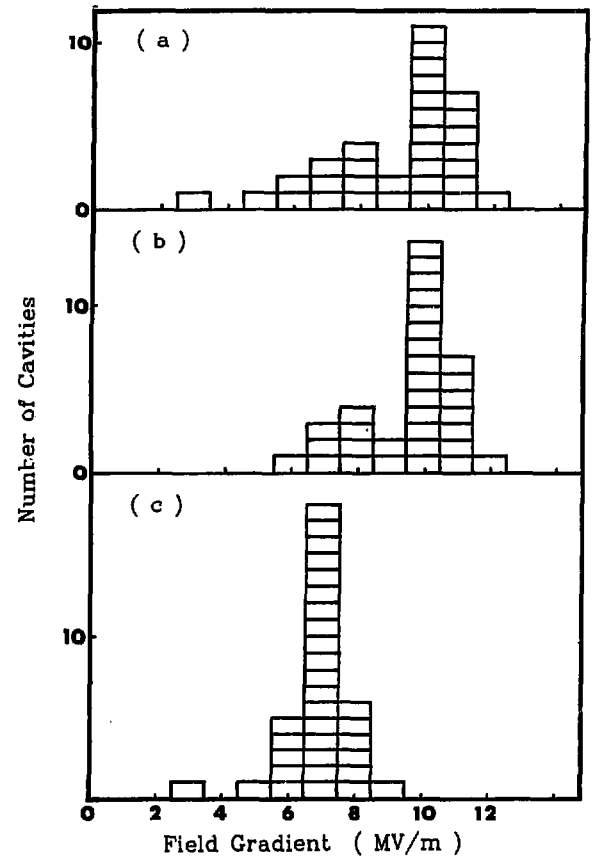
Figure 6: Eacc of TRISTAN cavities; (a) 1st cold test, (b) after grinding or re-treatment, (c) after fully equipped ( Horizontal Test ).

As shown in Figure 6(a), The designed specification of 5 MV/m has been achieved in thirty cavities without any rework. Eacc of 10 MV/m were obtained by nineteen cavities at the 1st vertical test without any processing, Eacc of other cavities were limited by strong field emission or thermal breakdown.

Figure 6(c) shows the maximum Eacc of fully equipped cavities at horizontal tests. Though sufficient RF aging has not given to the cavities, some of them show the degradation of Eacc and  $Q_0$  as compared with that of the vertical tests.

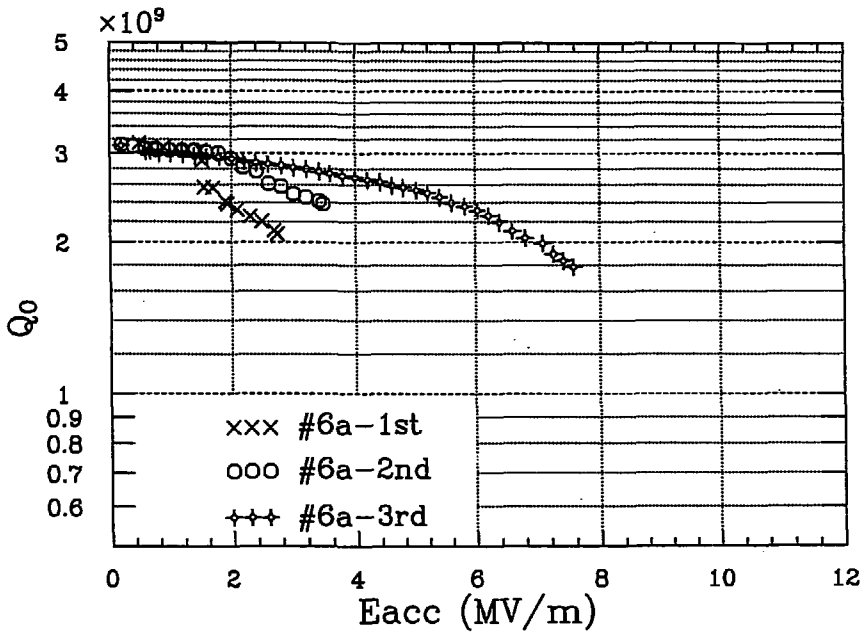
Figure 7:  $Q_0$  and  $E_{acc}$  of TRISTAN #6a cavity.

At the 1st vertical test of #6a cavity,  $Q_0$  switching was observed at 1.8 MV/m and Eacc was limited at 2.4 MV/m (Figure 7). The field gradients of five passband modes were measured and compared to find the breakdown cell. In Figure 8, calculated field profile along the beam axis and the positions of maximum  $E_{ap}$  for all modes are shown also. Maximum  $E_{ap}$  of the modes, where the highest  $E_{ap}$  was built at the center cell were limited at 5 MV/m. Then 384 carbon resistors were affixed to locate the bad spot on the center cell. After warming up, the cavity was visually inspected and a large fissure (8 cm) was confirmed near the equatorial welding seam (Figure 9). X-ray photographs could give no informations. This fissure was ground off with subsequent electropolishing and measured again. The Eacc of the cavity could be improved by repeating these processes twice and reached to 7.6 MV/m. After the first rework, the fissure seemed to be removed completely, but the Eacc were limited at 3.5 MV/m and the carbon thermometers indicated the heating spot at the same position as before. To eliminate the fissure completely, it was necessary to remove this spot by 0.3 mm.

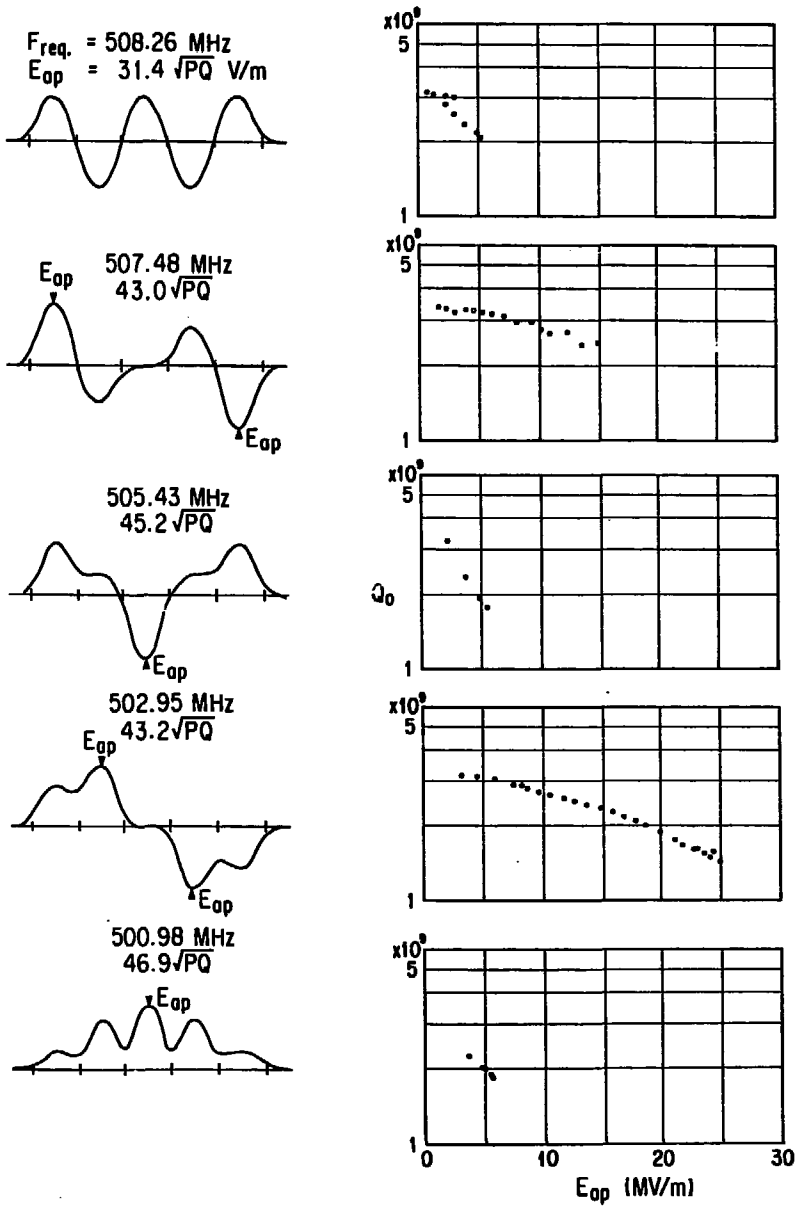
Figure 8: Passband modes measurements of #6a cavity.
