Corrosion Behavior of 18/8 Stainless Steel and Nickel-Plated Low Carbon Steel in Cassava Fluid

This research work investigated the corrosion resistance of nickel-plated medium carbon steel and 18/8 stainless steel in cassava fluid (i.e. containing hydrogen cyanide). It simulated the effect of continuous use of the materials in a cyanide environment where corrosion products are left in place. Low carbon steel sample was nickel electroplated at 4V for 35 minutes. The plated sample, the unplated and the 18/8 stainless steel were then subjected to a cassava fluid environment for thirty days. The electrode potentials, in mV (SCE), were measured every day. Weight loss was determined at intervals of 5 days for duration of the exposure period. The result showed little corrosion attack on the nickel-plated steel on the fifth and tenth days which quickly dropped to zero by the 15th day and remained at the passive state till the 20th day when corrosion picked up again increasing steadily, linearly until the end of the test day. Corrosion of the 18/8 stainless steel was very low as well decreasing till the last day of the test. The pH of the cassava solution which initially was acidic because

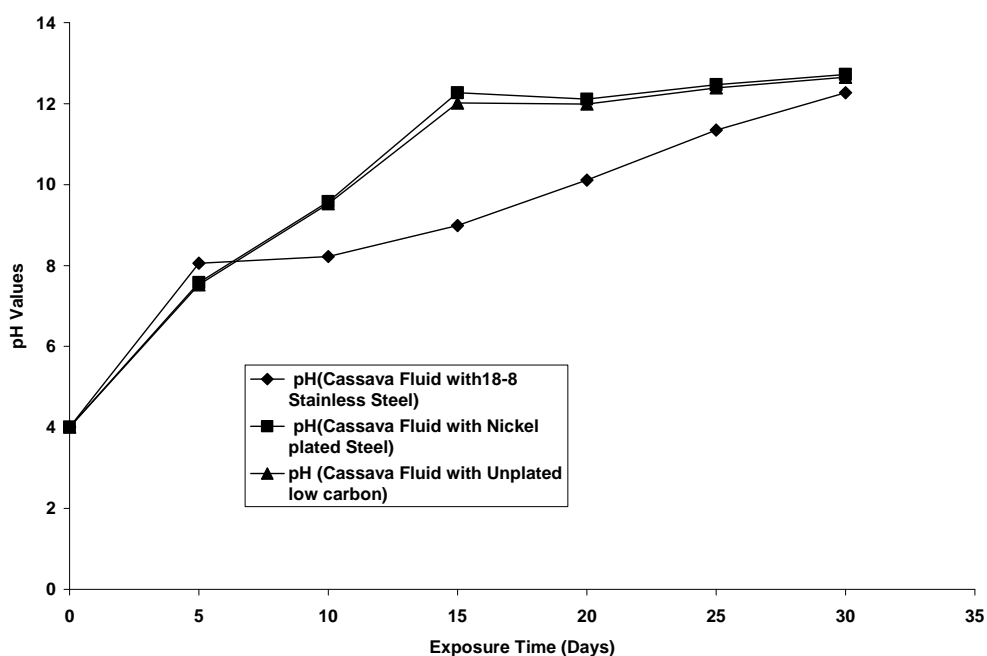
Table 1 shows the nominal chemical composition of the steel samples used while Table 2 shows the average properties of cassava fluid. The electroplating mass gains, and corresponding coating thicknesses value, for the zinc plated steel sample is shown in Table 3. Figure 1 shows the variation in pH values for cassava fluid during the corrosion test period. It shows the pH of the corrosive fluid changing from acidic to neutrality and then to alkalinity at the end of the corrosion test.

Fig. 1. Plot of pH values of Cassava Fluid during Corrosion of 18-8 Stainless Steel and the Low carbon Steels.

The un-plated sample showed potential increase from the fifth day till the thirteenth day after which it started decreasing again and relatively rapidly moved to values consistent with the exposure of bare steel (-550mV, SCE). The pH change during the immersion was significant. By the fourth day, pH had become neutral and on the 8th day was already alkaline. This affected the potential of the sample in the corrosion environment. Visible corrosion product for steel (i.e. rust) was apparent from early immersion resulting in the changing pH values.

18/8 stainless steel showed a cyclical trend of increase/decrease in potential from the first day from a potential of -200mV(SCE) until the 23rd day when it settled in the potential characteristic of bare steel(-550mV(SCE)) till the last day of test. The pH of the corrosive environment was seen to move from acidic to neutral and to alkalinity within 5 days. This significant trend affected the potential as well as the corrosion activity.

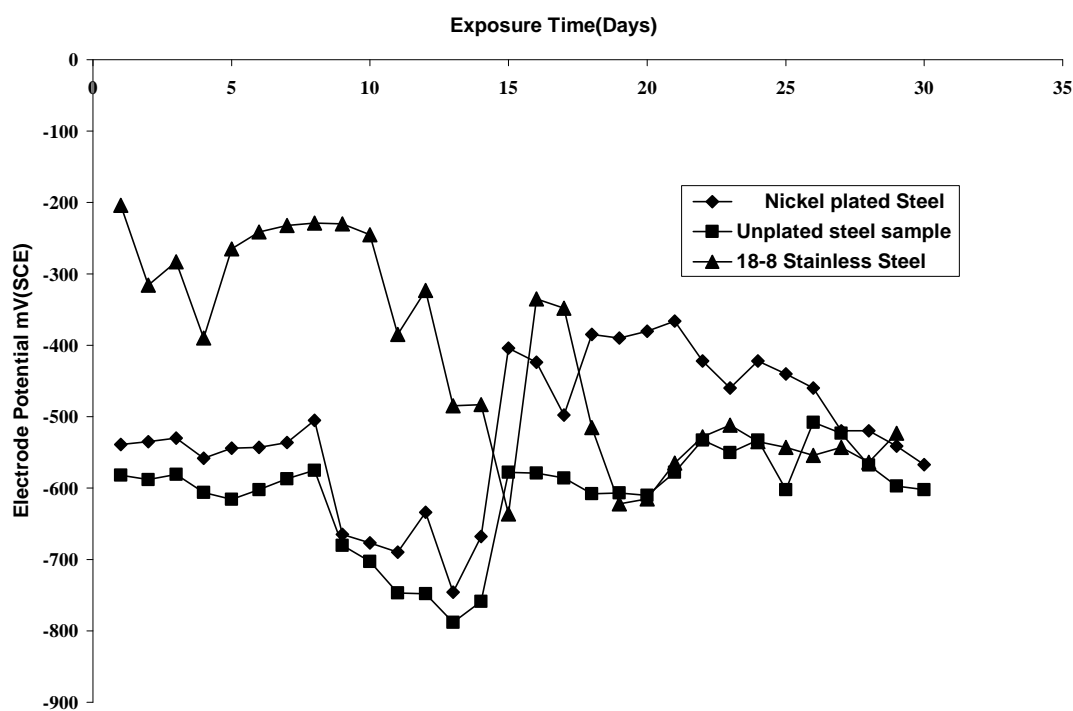
Figure 2 shows the variation in the electrode potential in mV obtained for 18/8 stainless steel, un-plated and nickel plated low carbon steel samples at various electroplating times.

For the unplated sample, the electrode potential increased from the fifth day until the thirteenth day after which it started decreasing again and relatively rapidly moved to values consistent with the exposure of steel. The nickel-plated steel started with a slightly higher potential than the unplated steel but followed the same trend as the unplated steel till the thirteenth day when it decreased into passivity from the fifteenth to the twentieth day.

After the 20th day, the potential started increasing again showing renewed corrosion activity. 18/8 stainless steel showed a cyclical trend of increase and decrease in potential from the first day till the 21st day when a steady plateau was reached till the 30th day.

Fig. 2. Plot of Electrode potential Versus Exposure Time for 18/8 Stainless Steel and unplated and nickel plated low carbon steel samples

The plated sample's trend of increasing potential from the fifth day till the thirteenth day when it decreased into passivity till the twentieth day is traceable to the changing pH of the corrosion environment as well. After the 20th day, the potential started increasing again showing renewed corrosion activity.

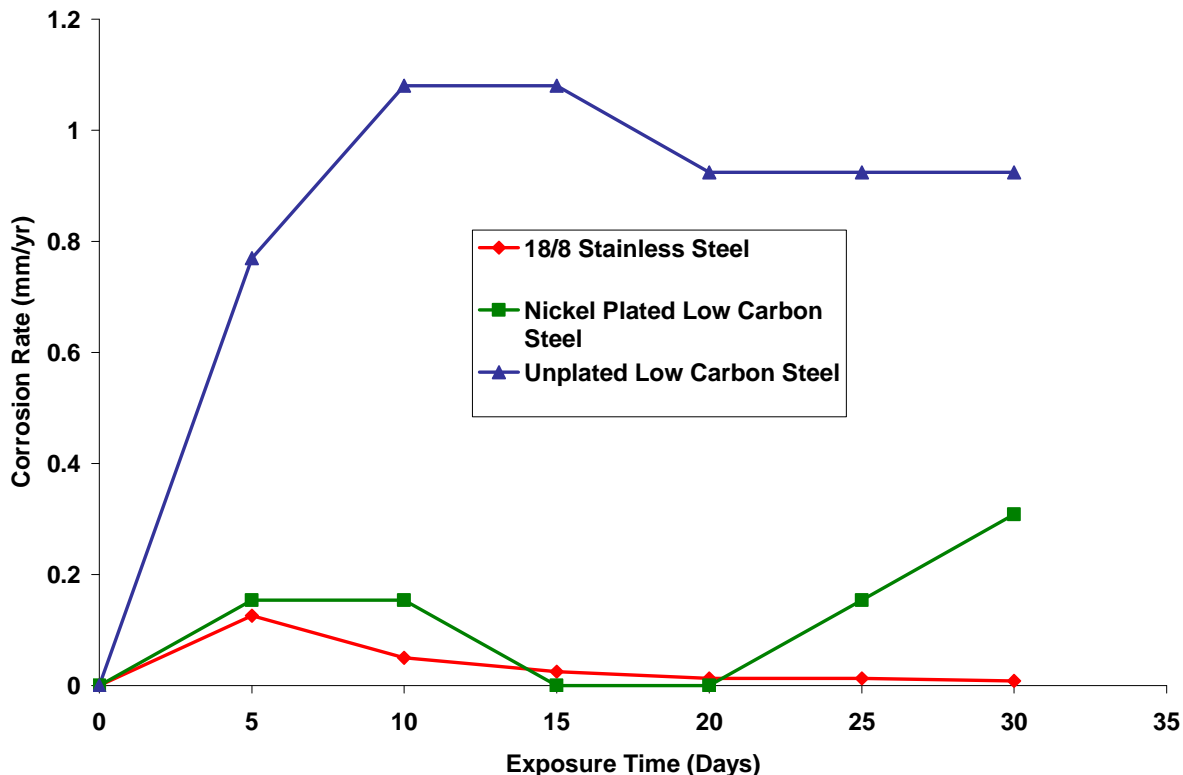
Figure 3 shows the variation of corrosion rate in mm/yr for 18/8 stainless steel, the nickel plated low carbon steel sample as well as the corrosion rate of the un-plated sample immersed in cassava fluid. It shows a relatively low corrosion rate experienced by the nickel plated steel in the first 10 days of immersion compared to the corrosion rate of the unplated steel. Corrosion rate was observed to drop to zero on the 15th day and remained zero till the 20th day when a renewed corrosion activity commenced and increased linearly till the end of the test. The 18/8

stainless steel had relatively very low corrosion rate compared to the unplated steel in the first five days. The corrosion rate continued to drop till the end of the test.

Fig. 3. Superimposed Plot of corrosion rate Versus Exposure Time for 18-8 Stainless Steel, Nickel Plated Low-Carbon Steel And the Unplated Low Carbon Steel

The extent of susceptibility to corrosion in natural fluids depends on the aggressiveness of chemical reactivities, transport properties of environment, concentration of corrosion species in the medium (pH), the metallurgy of the alloy sample and temperature of the corrosion medium⁹. In the cassava fluid, the corrosion rates of all the samples were observed to be influenced extremely by the changing pH of the corrosion environment. Corrosion rate of the 18/8 stainless steel decreased steadily after the fifth day because the pH had changed from acidity to alkalinity within five days. This decreasing trend continued till the last day of the test.

For the nickel plated sample, there was active corrosion activity up to a pH of 12 which was the 15th day of exposure in the corrosion environment. Passivation was observed at a pH of 12 which was the 15th day and moved out of passivation on the 20th day with a pH of 12.5. Thus, the corrosion rate for the nickel plated sample went into passivity with no corrosion occurring on the 15th to 20th days when the pH hit 12 and at a pH of 12.5 renewed corrosion activity began. This is showing that E-pH diagram for Ni-CN⁻ prevalence diagram has a thin passive segment between pH of 12 and 12.5 after which corrosion species become prevalent.

The unplated steel was experiencing increased high level corrosion activity up till the fifteenth day rising from a pH of 4.0 to 12 after which there was a decrease in corrosion rate on the 20th day remaining constant till the end of the test. This decrease corresponds to the decreased potential from -770Mv(SCE) to -550Mv(SCE) which is characteristic of bare steel and this potential remained steady till the end of the test.
