# Characteristics, Impacts and Risks of Dammed Lakes Induced by Debris Flows at the Wenchuan Earthquake Areas

After the Wenchuan Earthquake, many large-scale debris flows blocked rivers, generated dammed lakes, and produced outburst flood at the seriously hit areas. This paper mainly discussed the formation, outburst, impacts and risks of debris flow dammed lakes. The field investigation showed that the dammed lakes were created by debris flows from gullies and hill-slopes as well as the combination of debris flow and landslides, and also distributed along rivers step-by-step. The height of dams and the length of dammed lakes along river channel varied from 4 m to 18 m and from 400 m to 5000 m, respectively, and the reservoir capacity of dammed lakes were from  $1.5 \times 10^5 \text{ m}^3$  to  $3 \times 10^6 \text{ m}^3$ . Due to geomorphological impact, dammed lakes commonly partially outburst along their front of debris flow deposition dams (1/4 - 1/3 outburst) or the suture between debris flow and landslide, and hardly completely outburst. Moreover, the subsequent debris flows continuously increased the magnitude and height of dams, not only increasing the stability of a sing

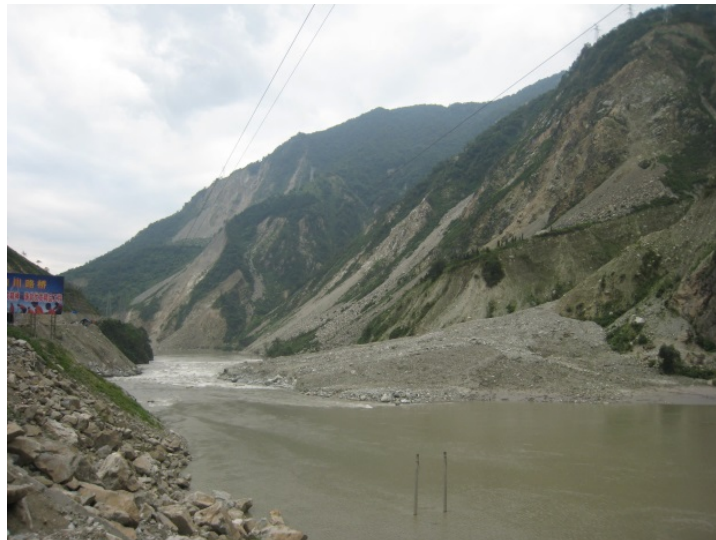
**Figure 2.** Dammed lakes formed by gully debris flow at Min River.

Hill-slope debris flows generally occur at the slopes with over 40% of slope gradient and abundant solid materials accumulation. After the Wenchuan Earthquakes, the deposits of debris avalanches and landslides provided a mass of loose solid materials and accumulated in steep slopes with 50% - 80% slope gradient. Moreover, the height of slope accumulation ranges from 100 - 200 m, which prepare adequate dynamic energy for debris flow formation. When intensive rainfall or rainstorm occurs, loose sediments are easily initiated and formed into debris flow and rapidly discharges into river, blocks it and produces dammed lakes. The dammed lakes induced by hill-slope debris flows appeared along the Rivers of Min, Jian, Yuze and Mianyuan (**Figure 2** and **Figure 3**).

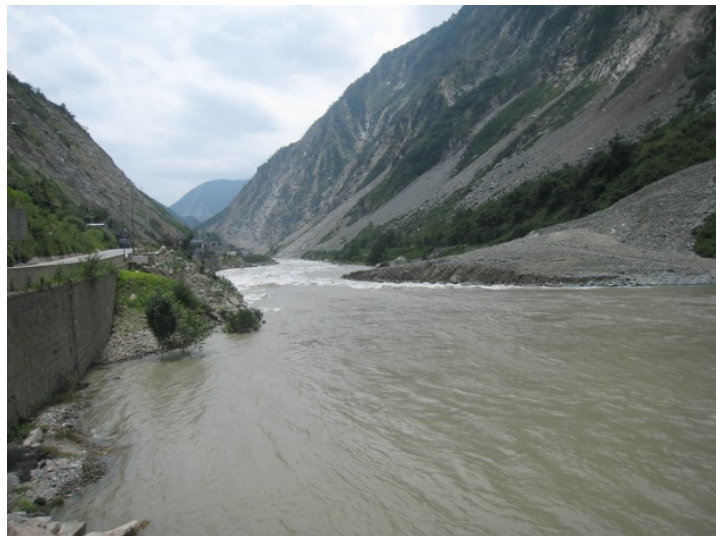
**Figure 3.** Dammed lakes formed by hill-slope debris flow at Min River.

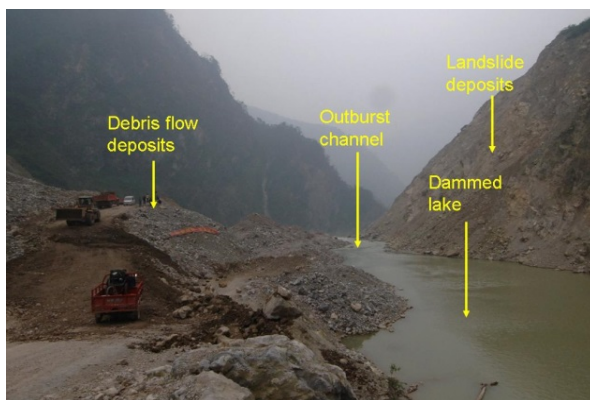
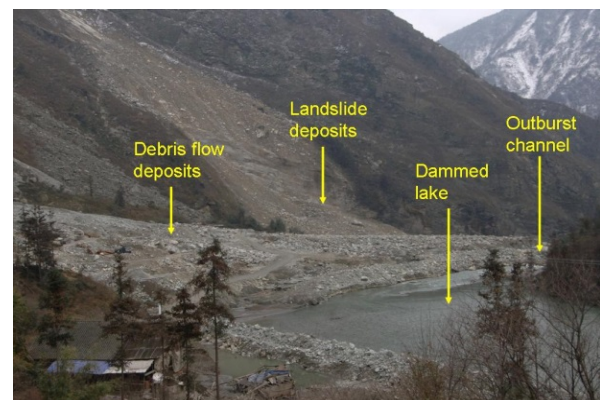
**Figure 4.** Dammed-lake formed by debris flow and landslide ((a) at Mianyuan River; (b) at Yuzi River).

Some dammed lakes were also generated by the combination of debris flow and landslides. The debris flow and landslide, located at the same section but the different bank, block river partly, respectively, so that the river is blocked completely and the dammed lake was formed, for example the Xiaogangjian dammed lake at Mianyuan River (**Figure 4(a)**). Meanwhile, the nearing debris flow deposit and landslide body at the same bank also can jointly block river and create dammed-lake. The landslide body occupies the partial space of the outlet of debris flow gully and increase the height and magnitude of debris flow deposition dam, moreover, the volume and stability of the whole dam is strengthened (**Figure 4(b)**). As a result, the dammed lake is strengthened and very difficult to outburst completely. These kind of dammed lakes majorly appear in the river section where landslides, rock falls and debris flow gullies densely distribute, for example the sections of from Yinxiu to Gengdaalong Yuzixi River and the Mianyuan River.

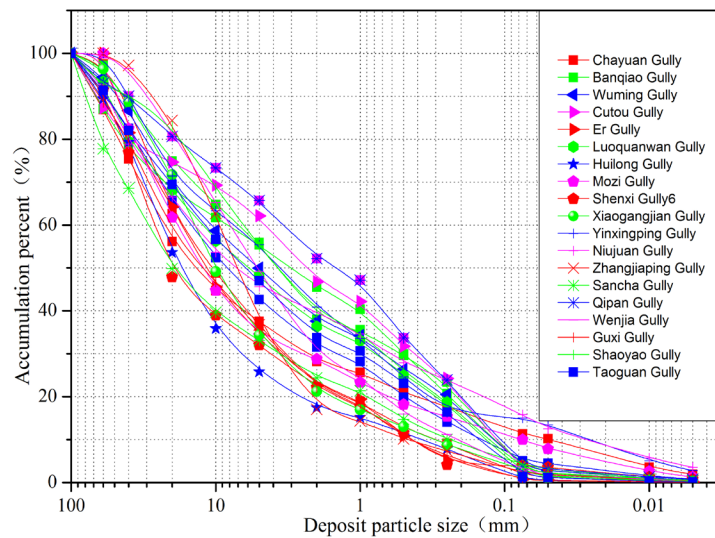
**Figure 5.** Particle size curve of debris flow dam at the Wenchuan Earthquake areas.

Debris flow deposits, whose sizes of solid grains range from  $\mu\text{m}$  to 10 m, are the dominating of the dams. The investigation showed the materials with bigger than 100 mm and 1000 mm occupy 48% - 56% and 4% - 9%, respectively. The test data of debris flow deposition dam samples (<100 mm) showed in **Figure 5**, and indicated great particle variation of debris flow deposits due to different material sources and their lithology. The  $D_{50}$  of debris flow deposits ranged from 2.1 mm - 21.5 mm. According to the calculation formula for debris flow density which was established by Yu [23], the density of debris flow deposits were from 1.88  $\text{g}/\text{cm}^3$  to 2.17  $\text{g}/\text{cm}^3$ , and those with over 2.0  $\text{g}/\text{cm}^3$  and more than 1.95  $\text{g}/\text{cm}^3$  occupied 77.7% and 90%, respectively. The high-density debris flow formed dams, which is difficult to completely outburst although their height are generally less than 20 m because that the deposition dam (soil) are complete saturated and no pores, with high viscosity and river flow are not enough to initiate and make debris flow dam failure to outburst. Moreover, after the Wenchuan Earthquake, landslides, rock fall, and debris avalanches provided abundant loose solid materials and the percentage of gravels and stones (>1000 mm) in debris flow deposits were higher than before the Earthquake. Those stones bigger 1000 mm of some debris flow deposition dam were about 5%, which also improve the stability of the dam. Therefore, debris flow dammed lakes were difficult to outburst completely even though the dam were absolutely overflowed.

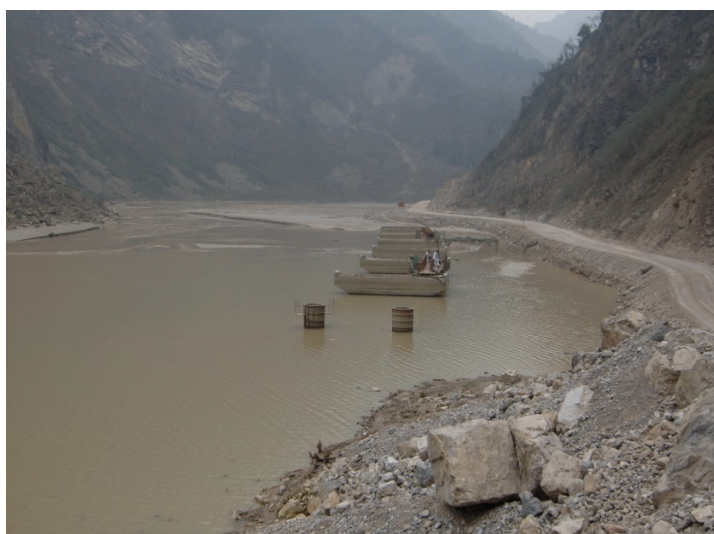
**Figure 6.** Dammed lakes preventing highway reconstruction at Mianyuan River.

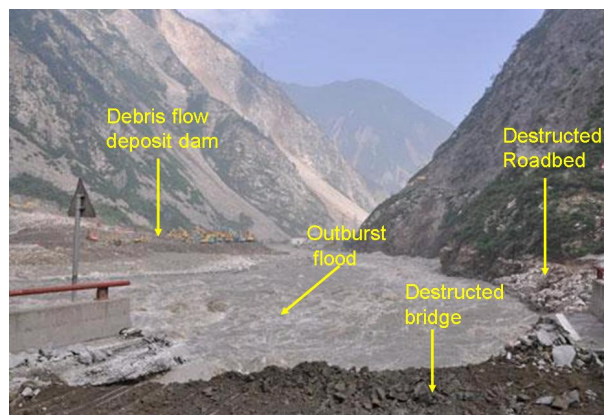
**Figure 7.** Outburst flood of dammed lake induced by Gaojia Gully destructed Dujiangyan-Wenchuan High-way at the outlet of Luoquanwan Gully.

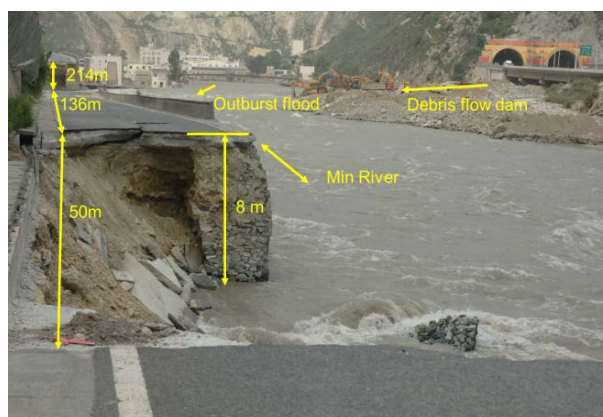
**Figure 8.** Outburst flood of dammed lake induced by Qipan Gully destroyed Dujiangyan-Wenchuan Highway at the outlet.

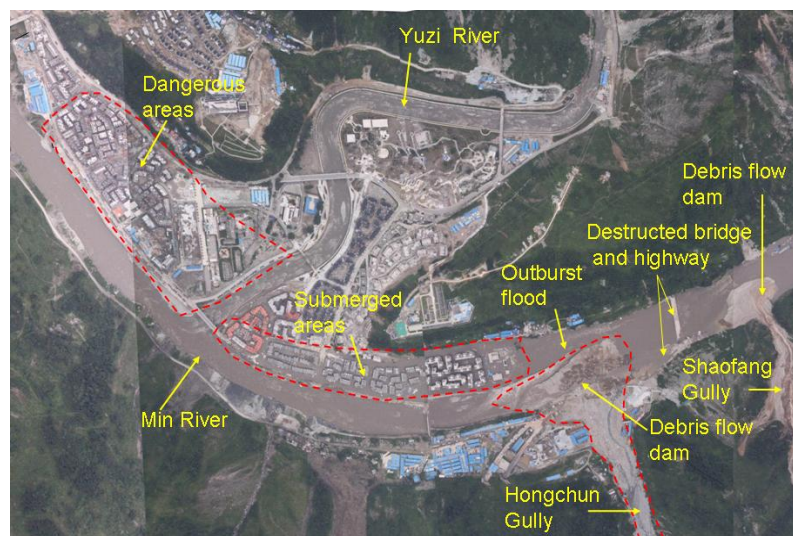
**Figure 11.** Yinxiu town threatened by 8.14 debris flows and outburst flood of dammed lakes.

Moreover, some big watersheds with over  $5 \text{ km}^2$ , including the gullies of Yeniu, Taipingyi, Er and Luoquanwan, Cutou and Qipan also occurred large debris flows under the condition of rainstorm in 2013, which could block Min River and form bigger dammed lakes and further increase the risk of outburst flood. Step debris flow dammed lakes also prevent the recovery of water power plants along Min River due to water level increase and quantity of sediment deposition. For example, a dammed lake caused by hill-slope debris flow on July 10, 2013 at the southern exit of Chediguan tunnel not only submerged Futang Water Power Plant, but also bury some

equipment due to a mass of sediment from upstream. Debris flows and the following dammed lakes will continuously endanger Yinxiu town and the highway from Yinxiu to Wenchuan, especially the high risk section where road bed is lower or close to the height of water level of dammed lakes or highway is easily scoured or destructed, for example, the highway Yinxiu to Laohuzui and from Gaojia Gully to Huaxi Gully.
