Degradation of Polymer & Elastomer Exposed to Chlorinated Water—A Review

Nikesh B. Samarth, Prakash A. Mahanwar*

How to cite this paper: Samarth, N.B. and Mahanwar, P.A. (2021) Degradation of Polymer & Elastomer Exposed to Chlorinated Water—A Review. *Open Journal of Organic Polymer Materials*, 11, 1-50.
<https://doi.org/10.4236/ojopm.2021.111001>

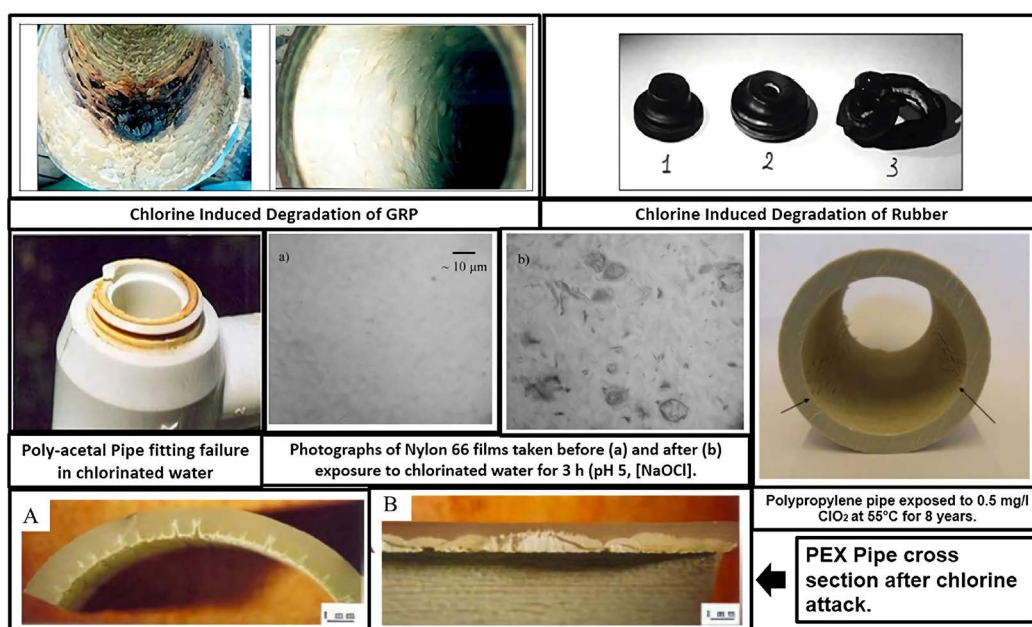
Figure 1. Actual field failure example of polymeric components by Chlorine induced degradation.

propose that a statistical cleavage leads in most cases to narrowing of the distribution. Several failure examples of polymeric components during service span time are shown in **Figure 1** & **Figure 2**.

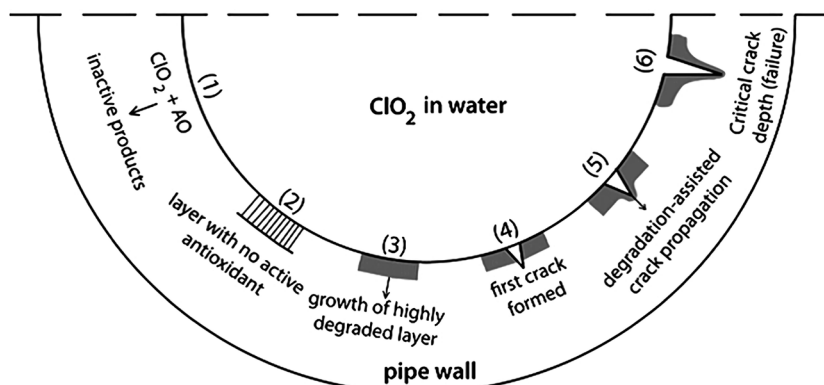
Figure 2. Sketch of mechanisms underlying failure of a pressurized polyethylene pipe exposed to water containing ppm levels of chlorine [Reprinted with Permission] [29].

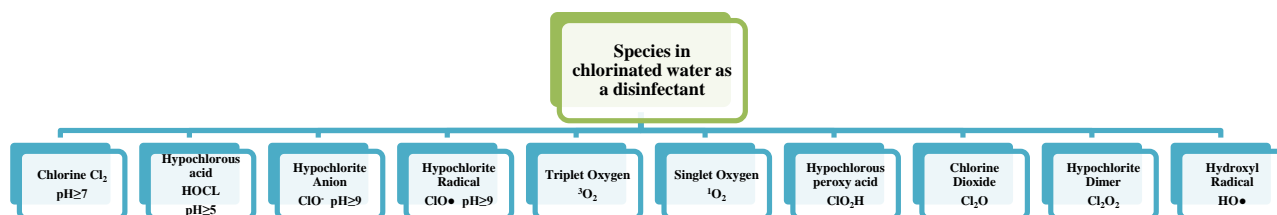
Figure 3. Species in chlorinated media responsible for degradation of polymer and elastomer [14] [23] [33] [34].

Chlorinated aqueous media are intrinsically unstable. They change character with time because many of the chlorinated species are highly oxidative and they undergo reaction. Substances containing chlorine are used at low concentrations in fresh water to avoid the spreading of infections. The benefit is that many human lives are saved. The negative consequence is that essentially all materials in contact with the chlorinated medium degrade relatively rapidly. Many strongly oxidative species can be present in chlorinated water and polymers in contact with such media may deteriorate by oxidation. When chlorine is added to water for disinfection, it transforms to hypochlorous acid tends to chain fracture and chain disentanglement. Chlorine is a strong oxidizer, which is capable of breaking the carbon-to-carbon bonds of the polymer chain, effectively disintegrating it. It is well established that singlet oxygen is a reactive intermediate capable of oxygenating olefins. By extension, singlet oxygen is thus a key reactive intermediate involved in the degradation of many polymeric materials under a variety of conditions. The susceptibility of a given polymer to reaction with singlet oxygen often depends on the structure and thermal history of that particular polymer sample [30] [31]. Specifically, for polymers that have been exposed to high temperatures (e.g., $T_g < T < T_m$), thermal degradation can result in the formation of functional groups (e.g., olefinic residues) that readily react with singlet oxygen. The products of these reactions (e.g., hydroperoxides) can, in turn, initiate chain reactions that ultimately contribute to the further degradation of the polymer [32]. The species in chlorinated media responsible for degradation of polymer are shown in **Figure 3**.

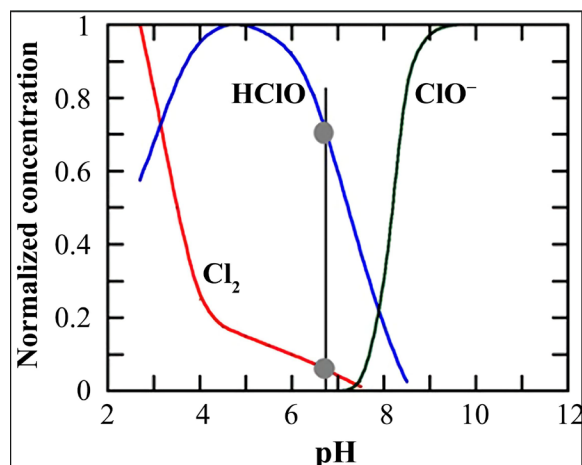
Figure 4. Normalized (with respect to maximum concentration) concentration of Cl_2 , HOCl and ClO^- as a function of pH in aqueous solution [4] [18] [26] [Reprinted with permission].

As illustrated in **Figure 4**, “chlorinated water” is most accurately described in terms of the pH-dependent concentration profiles of four species: Cl_2 , $HClO$,

ClO^- , and singlet molecular oxygen, O_2 . Alkaline systems with a pH greater than 9 are characterized by a high concentration of ClO^- . Upon acidification with HCl , the concentration of HClO correspondingly increases, reaching a maximum at a pH of 5. At the same time, one must consider the equilibrium shown in Equation (1) in which molecular chlorine, Cl_2 , is formed [37] [38]

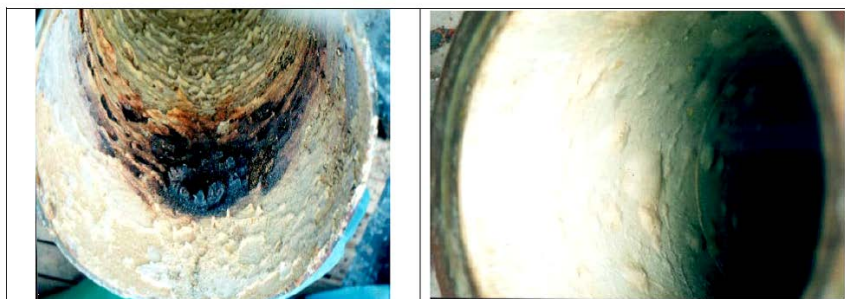
Figure 5. Chlorine degradation (left) and hydrogen chloride induced blistering (right) of a GRP pipe.

Molecular chlorine present in aqueous solutions will cause a gradual reduction in laminate thickness (see **Figure 5** & **Figure 6**) and mechanical properties. The active form of chlorine in an aqueous solution depends on the pH of the solution, which is controlled by the following reactions:

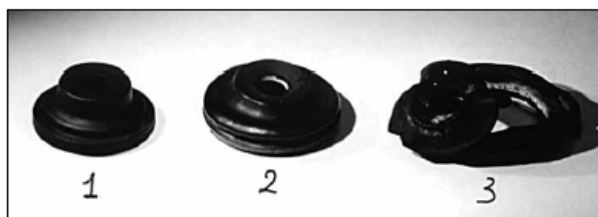
Figure 6. Example of chloramines induced elastomer degradation of a rubber components from the appliances industry.

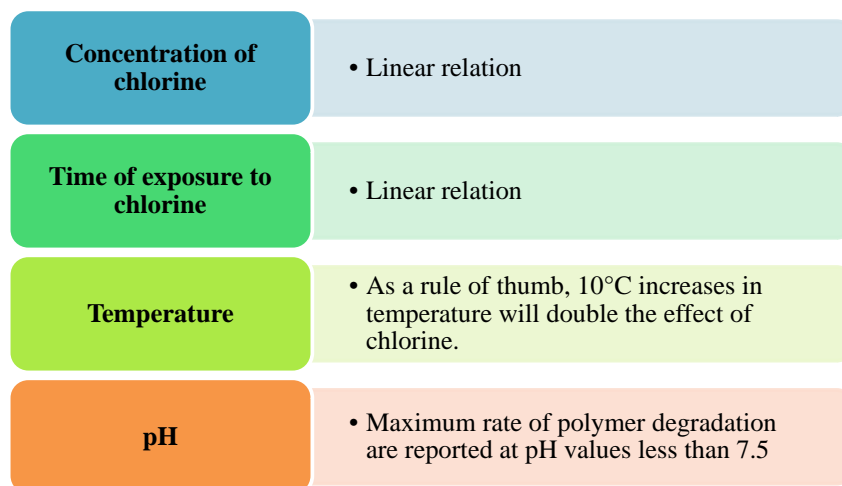
Figure 7. Factors influence the degree of attack on the linear material.

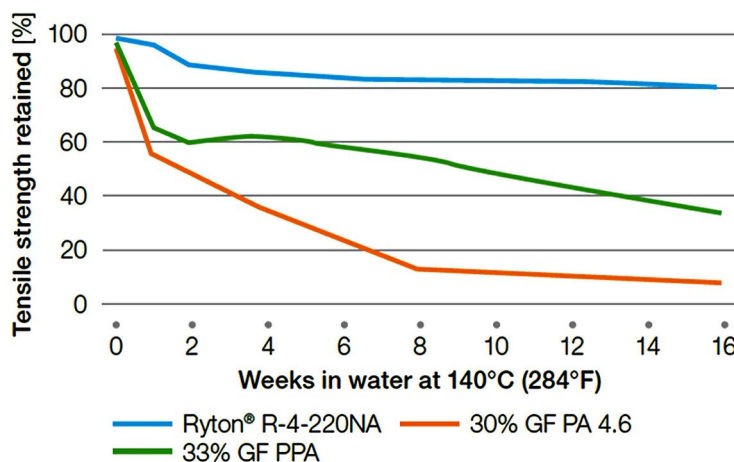
Figure 8. Tensile strength retained after 16 week immersion in hot chlorinated water (140°C) [Solvey Bulletin 2002].

The study of Solvay was undertaken to demonstrate the suitability of Ryton[®] PPS (polyphenylene sulfide) for such service. The performance of Ryton[®] PPS compounds compared to other high temperature engineering thermoplastics was also evaluated. Elevated temperature immersion tests have shown that PPS polymer is not attacked by hot water. These tests involved total immersion of standard test specimens in hot water for a period of time, and stress testing after exposure to determine retention of mechanical strength. For example, after exposure to 93°C (200°F) water for twelve months, unfilled Ryton[®] PPS retained over 90% of original tensile strength. The slight drop in tensile strength was likely due to thermal aging rather than chemical attack, and similar retention of mechanical strength after hot water exposure was observed at temperatures up to 149°C (300°F). Many other polymers, such as polyamides (nylons) and polyesters, will actually be hydrolyzed in hot water; the polymer chain is broken down and the plastic material is degraded (**Figure 8**).

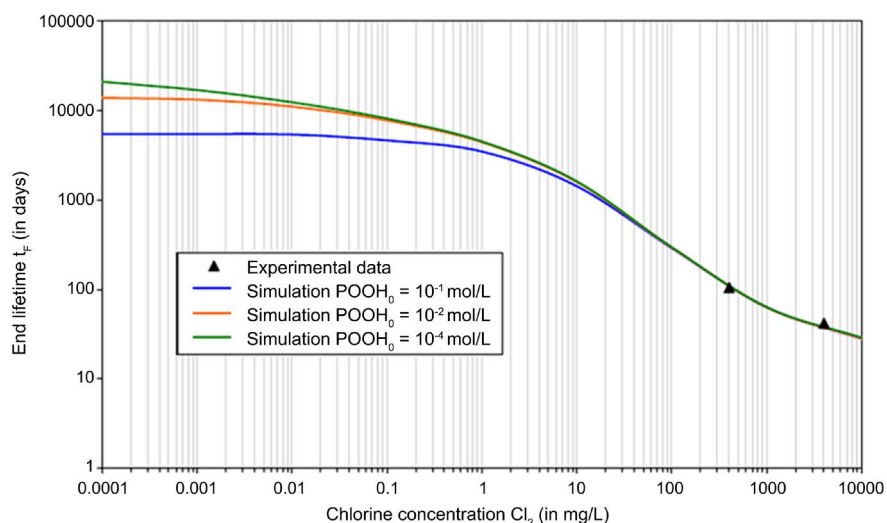
Figure 9. Evolution of time to embrittlement of polyethylene surface in contact with water as a function of chlorine concentration the curve corresponds to simulation by kinetic modelling for unstabilized polyethylene [Reprinted with permission].

According to the model explained by Devilliers *et al.* (2011) [36], it is now possible to simulate the molar mass drop as a function of the chlorine concentration at 20°C. In order to predict mechanical behaviour changes during long-term ageing, the coupling between the chemical degradation and the mechanical properties is needed. For this purpose, it has been proposed that the chemical degradation induced by chlorine is responsible for the embrittlement mechanisms occurring at the inner surface [124]. In the case of polyethylene films, it is well known that polyethylene is brittle since M_w is below the critical molar mass (M'_c) value; close to 40 kg·mol⁻¹ [126]. More precisely, it has been

shown that this critical molar mass value is intimately linked with the chemi-crystallization process leading to reduce amorphous layer thickness. Once the amorphous layer thickness is below a specific critical value (≈ 6 nm for polyethylene), the mechanical behaviour starts to exhibit a brittle behaviour [35]. In a preliminary approach, considerate can be assumed that the time to embrittlement (for films or oxidized layers) is closely associated with any Mw decrease lower than $40 \text{ kg}\cdot\text{mol}^{-1}$. According to **Figure 5(a)**, **Figure 5(b)**, the time to embrittlement for both stabilized and unstabilized polyethylene is roughly 5 days and 15 weeks for 4000 and 400 mg/l ageing conditions, respectively. These data are plotted in **Figure 9** where the x-axis is the chlorine concentration using a log scale. The curve corresponds to the simulation resulting from a combination of the kinetic model and the selected embrittlement criterion $M'C$, for a chlorine concentration range from 0.01 to 10,000 mg/l as applied to an unstabilized polyethylene. Thanks to this curve, one can observe two domains: the first domain is where the chlorine concentration is below 0.01 mg/l and corresponds to the situation in which oxidation is mainly controlled by intrinsic polyethylene thermal oxidation, *i.e.* hydroperoxide decomposition (no chlorine effect). The second domain corresponds to the 10 - 1000 mg/l range where the oxidation kinetics are governed by the chlorine concentration. This is most probably why no stabilizer impact has been observed in the latter case. In other words, the oxidative species generated by the chlorine concentration is higher than any generated by the stabilizers. Experimental results at 70 mg/l confirm this trend (see **Figure 9**). For both situations (0.01 - 10 mg/l), the oxidation kinetics are controlled by the initiation processes: hydroperoxide decomposition and chlorine initiation. As a result, it is to be expected that the stabilizer efficiency in this 0.01 - 10 mg/l range, which is the usual range observed in drinking water supply, is in operation.

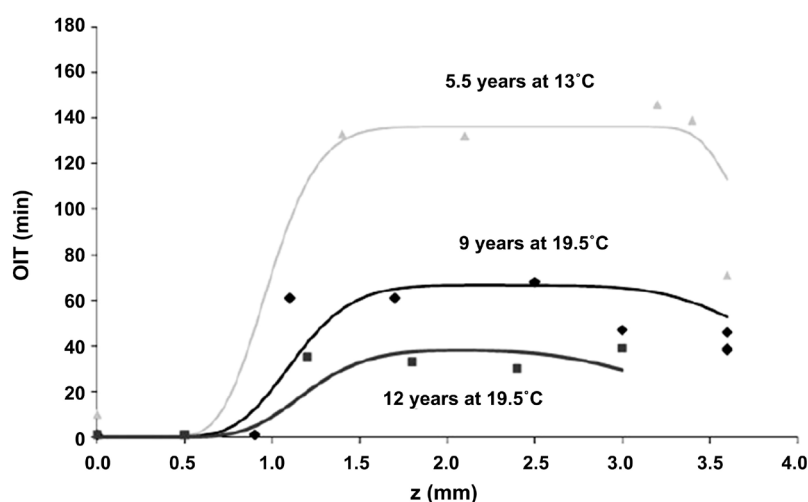
Figure 10. Example of simulations of oxidation induction time profiles (continues line). Comparison to experimental ones determined by differential at 190°C in pure oxygen on pipes naturally aged in the presence of DOC.

The exposure conditions of the pipes (concentration of disinfectant in water, water temperature and pressure, water oxygenation, and their respective seasonal fluctuations) in the drinking water distribution network. This model has been successfully applied to chlorine dioxide (DOC). In general, the water temperature and the DOC concentration range respectively between 9°C and 24°C and 0.1 ppm and 0.3 ppm (milligram per litre of water) from one site (of drinking water network) to another. For the sake of simplicity, in a first approach, the simulations have been made for the average values of 15°C and 0.15 ppm in water (*i.e.* for a concentration of DOC of $[Y^{\circ}]_{z=0} = 2.3 \times 10^{-6} \text{ mol}\cdot\text{l}^{-1}$ in PE) [127] [128]. The lifetimes have been calculated for a virtual pipe of 40 mm diameter and 4.5 mm thickness, made in a PE generation anterior to the PE 80 one, having an initial average molar mass of $MW = 150 \text{ kg}\cdot\text{mol}^{-1}$, and containing an initial Irganox 1010 ($n_{\text{AH}} = 4$) concentration equals to its equilibrium value ($[\text{AH}]_{t=0} = 1.8 \times 10^{-5} \text{ mol}\cdot\text{l}^{-1}$). Examples of simulations are given in Figure 10 and Figure 11. In each case, one observes a satisfying agreement between theory and experiment.

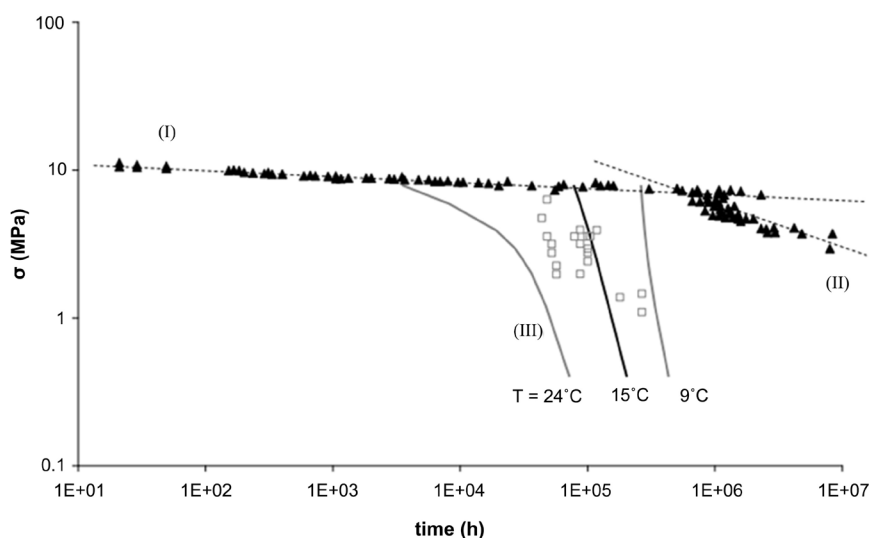
Figure 11. Simulation of regime (III) at three different water temperature (continues line). Comparison to lifetimes of Pipes naturally aged in the presence of DOC. The regression plot in pure water (without disinfectant) at 15°C (Δ) has been determined from experimental results.

A kinetic model has been built for the lifetime prediction of PE pipes transporting slightly pressurized (between 3 and 12 bars) drinking water disinfected by 1 disinfectants which are free radical reagents. This model simulates satisfyingly the degradation profiles (oxidation induction time, antioxidants and oxidation products concentration, average molar masses, etc), and via an empirical law, the “strain” in the pipe wall. The failure occurs when the “strain” reaches a critical value eF depending of the weight average molar mass MW in an elementary sublayer situated at a depth of 100 mm in the internal pipe wall.
