Panorama of the History of Coastal Protection

Authors: Charlier, Roger H., Chaineux, Marie Claire P., and Morcos, Selim

Source: Journal of Coastal Research, 2005(211): 79-111

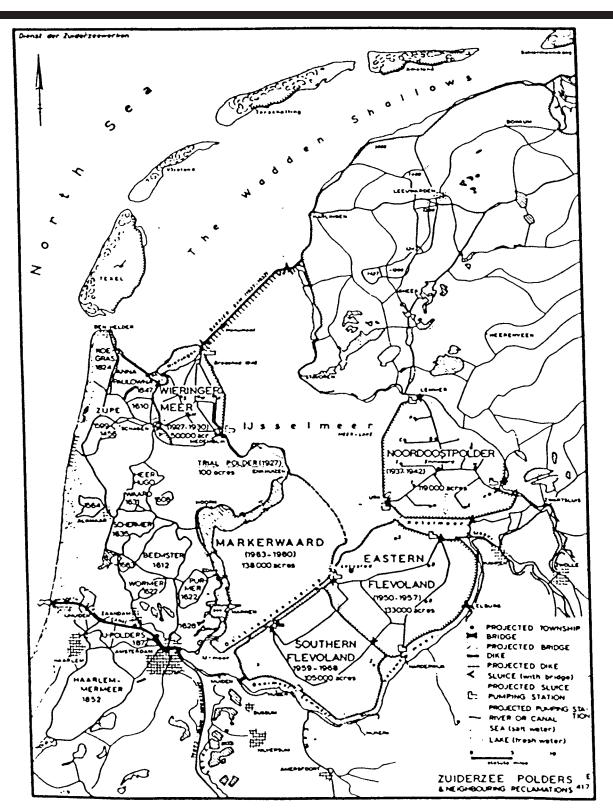
Figure 1. Reclamations in The Netherlands. Top left caption of figure reads "Dienst der Zuiderzee-werken." Bottom caption reads "ZUIDERZEE POL-DERS AND NEIGHBORING RECLAMATIONS."

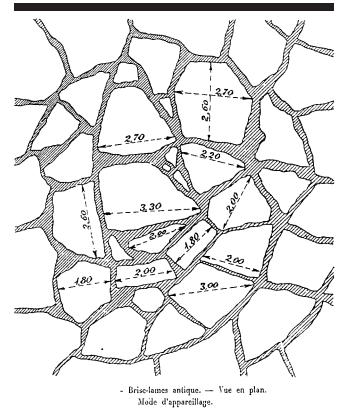
Figure 5. Upper surface view of the Great Ancient Breakwater. After Jondet, 1916.

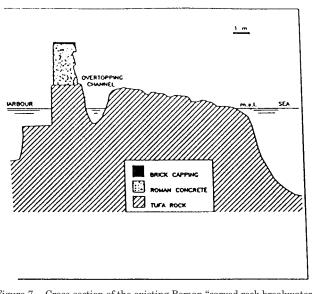
Figure 7. Cross-section of the existing Roman "carved rock breakwater" with overspill stilling channel at Ventotene (Built 2 BC).

Coastal defense history is, naturally, closely linked to harbor creation and development. Primitive breakwaters were put in place occasionally with ramps allowing the top of the waves to pass over them. Phoenicians had devised wave catchers by excavating holes and establishing trenches in the rocks lining the shores (RABAN, 1988). Carved breakwaters were cut out of bedrock: a suitable wave-absorber profile was created which had a gentle grooved slope at the waterline. The classical example dates from 2 before the present, is still visible at Ventotene; it had an over-spill. One may see in it an early version of today's Fontvieille breakwater (Principality of Monaco) (Figure 7).

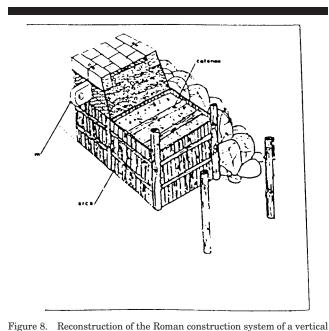
water with cast-in-situ concrete within wooden forms and tie-rods (Clementi, 1981).

Figure 9. Modern section of the Trajan island breakwater of Civitavecchia harbour.

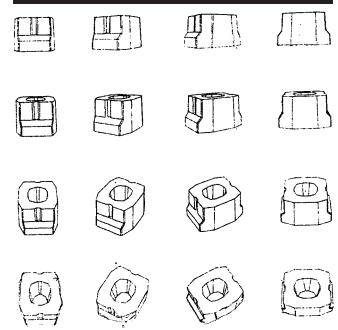
Figure 15. Various views of the "Haro" used in breakwater and groin construction.

As elsewhere, in the Mediterranean, engineers and environmentalists have second thoughts about hard structures, *e.g.* detached rubble mound breakwaters, are being replaced by star-shaped piles and perforated and articulated blocks somewhat reminding of the Belgian designed Haro^{TD}—and submerged barriers, all not infrequently combined with artificial beach nourishment, also by-passing. An environmental impact assessment is in process as regards mobile storm surge barriers (Figure 15).

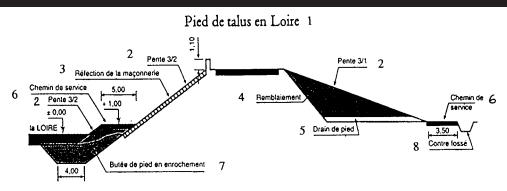
Figure 18. Reinforcement of the Levee Project (Loire River). Legend: 1. Talus foot in the Loire. 2. Slope. 3. Masonry repair. 4. Embankment. 5. Foot drain. 6. Service path. 7. Rubble mound foot block. 8. Counter ditch. (All measurements in meters).

embankments between 1904 and 1926 in such tidal rivers as the Loire. Made of wooden poles or stakes garnished with chestnut tree claires, a rubble-mound string allows to insure their foundation towards the bottom. Such groins had medieval forerunners, some of which still subsist, for instance at St. Georges-sur-Loire: they were constructed of small poles placed very close to one another with small size rubble stones, mostly covered by alluvions as time went by (Figure 18).

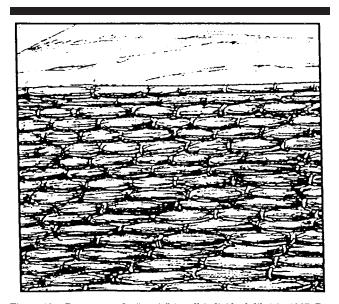
Figure 19. Revetment of a "turcie" (small individual dike) in 1967. Reproduced from a photograph from the Departmental Archives of Maineet-Loire by B. Rousseau.

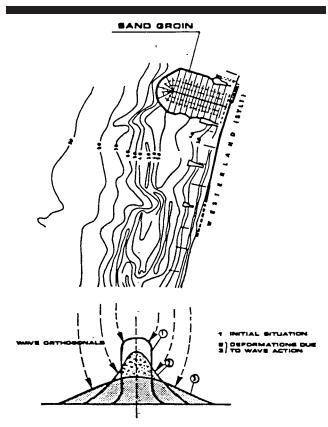
Figure 21. Construction of sand groin as coastal protection, Sylt, West Germany. Source: HAECON N.V., Ghent, Harbour and Engineering Consultants.

Along the coasts of Germany, especially those on the North Sea, situations similar to those of Denmark and The Netherlands prevailed throughout history. The eastern Friesland islands belong politically to Germany but differ in no way from their counterparts under Dutch sovereignty. Groins were implanted along the coast and some failures made history. Beaches on Sylt and Langeoog received artificial nourishment (CHARLIER, DEMEYER, DECROO, 1998) (Figure 21).

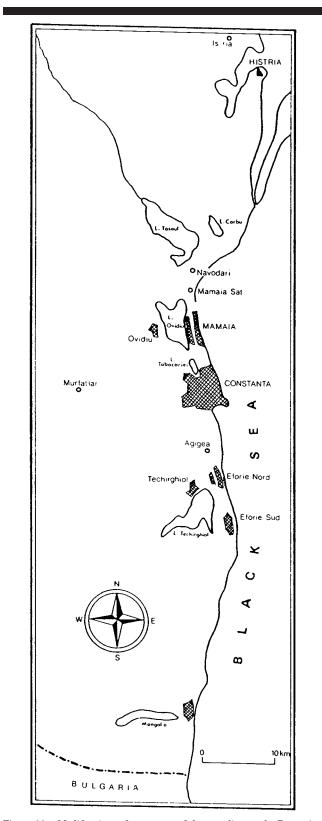
Figure 22. Modifications of a segment of the coastline on the Romanian sector of the Black Sea. The coastline has left inland several salt water lakes (*limans*), but currently the coast requires protection measures.

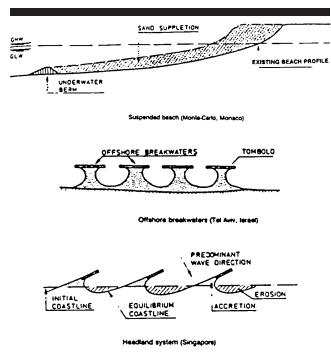
Figures 27–29. Some beach-restoration possibilities. Top, suspended beach (Monte Carlo, Monaco); Center, offshore breakwaters (Tel Aviv, Israel); Bottom, headland system (Singapore). Source: HAECON N.V., Ghent, Harbour and Engineering Consultants, Belgium.

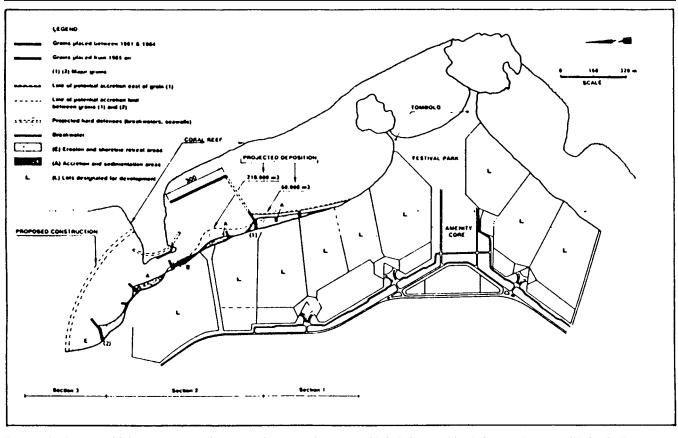
Figure 30A. Location of defenses, erosion, and accretion along some shore areas of Bali, Indonesia. After Indonesian Institute of Hydraulic Engineering.

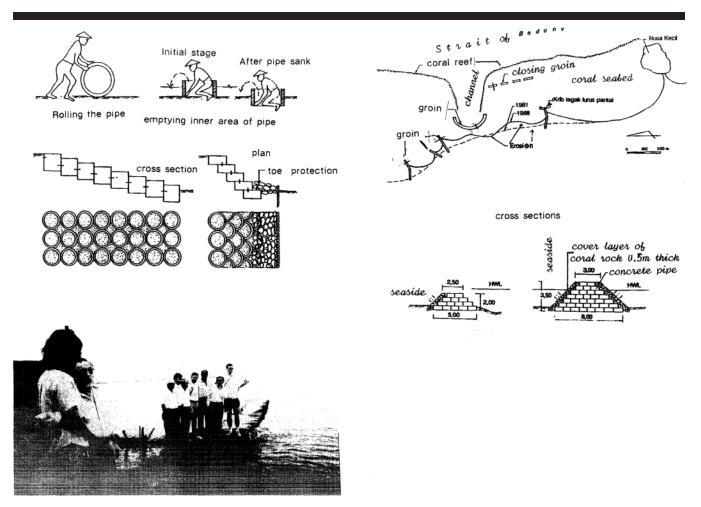
Figure 30B. Java, Indonesia. Concrete round pipes used to build breakwaters near a tourist resort (Belgian co-operation project. Author is second in picture front, to the left).

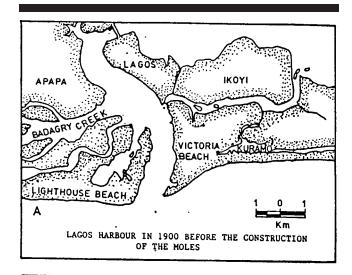
Figure 31. The Lagos coastline before (A) and after (B) the construction of the breakwaters (after IBE *et al.*, 1984).

The West African coastline, southwards of Senegal, has suffered severe erosion for decades, and land loss reached alarming and devastating proportions. Seawalls, groins and revetments have mostly been ineffective in stemming erosion. Local authorities ask for help in sand nourishment projects while recommending simultaneously semi-permeable groins, disused oil field hoses and sand-bagging. Construction of moles in Lagos has caused steady retreat of the coastline since 1900. Shoreline protection schemes include groins on Victoria Island near Lagos (Nigeria) (Figure 33) but also beach nourishment, sea-walls in Dakar (Senegal), groins on Jamestown Beach and revetments on Labadi Beach both near Accra, offshore breakwaters in Conakry (Guinea), St. Louis and Rustique (Senegal). "Local" methods are bulkheads, sand-mattresses and -bagging in Brass (Nigeria), timber groins, Chicoco blocks, wooden bulkheads and afforestation (Figures 31-34).

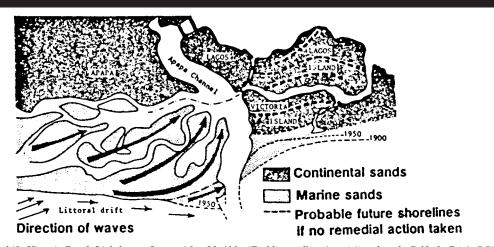
Figure 32. Shoreline shift, Victoria Beach Lighthouse, Lagos. After M. Akle, "Problèmes d'érosion côtière dans le Golfe du Bénin," Siren 29 (September 1985): 20–31.

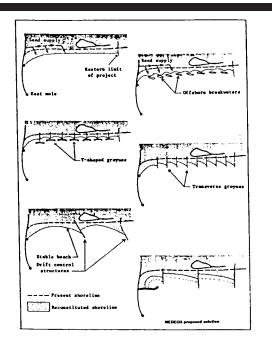
Figure 34. Proposed protection scheme for Kpémé and Anécho (Togo).

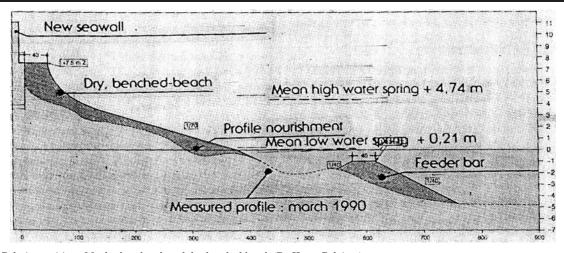
Figure 35. Relative position of feeder bar, beach and dry benched beach (De Haan, Belgium).

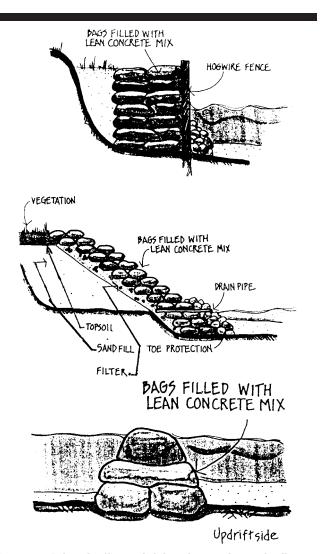
Figure 36. Relatively efficient, slightly sophisticated, in use locally since the fifties, these schemes may be a base for artisanal protection devices in developing countries: using bags filled with lean concrete and held with hog wire fencing an inexpensive "groin" may be constructed, even improved with filter and drain and toe protection. On the right, devices made of H-piles and railroad ties; pile-and-plank; anchored floating tires; a sloping model with concrete blocks or slabs, and rock filter with filter cloth.

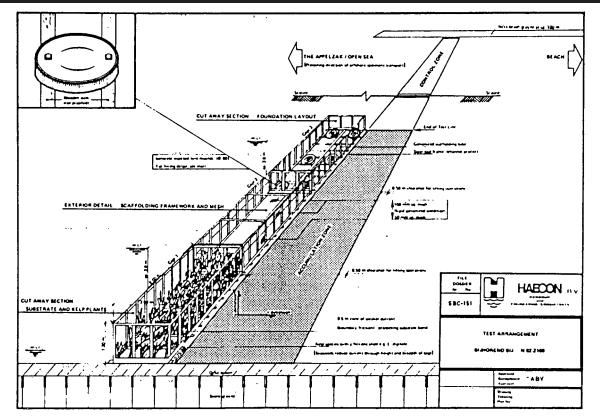
Figure 38. —Cages array for algae artificial reef. Source: HAECON N.V., Ghent, Harbour and Engineering Consultants.

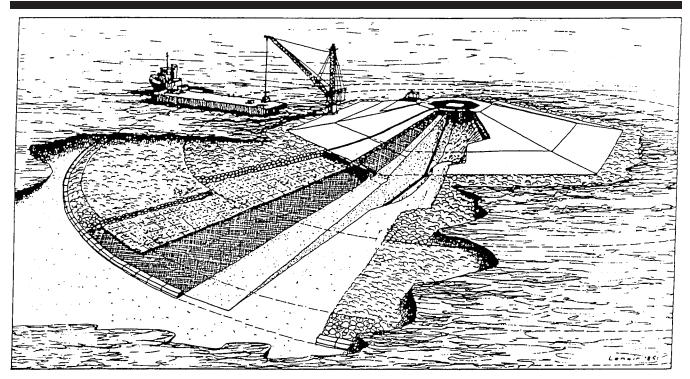
Figure 39. Boskalis Westminster's award winning design for a slope-protected, sand-fill island to be used by the Dutch hydrocarbon company NAM as a pipeline valve station.
