Performance of 0.75 mm Pitch MWPC's Operating at High Rate*

January 1989

*Presented by J. Kuzminski at the 1988 IEEE Nuclear Science Symposium, Orlando, Florida, November 8-13, 1988.

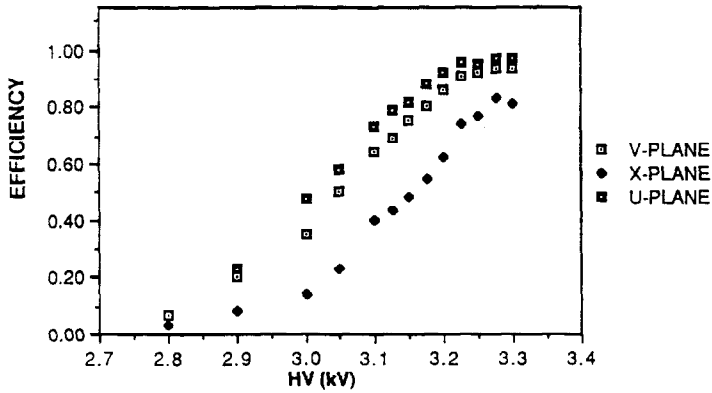
Figure 2: Plateau curves for the 0.75 mm pitch chamber (PC-B1) measured with a 300 GeV/c proton beam.

Fig. 2 and 3 show the plateau curves measured for PC-B1 and PC-B3 with a 300 GeV/c proton beam. The plateau curves for PC-B2 are very similar. During the whole run the 0.75 mm pitch chambers were operated on the low side of the high-voltage plateaus (3.25 kV for PC-B1, PC-B2 and 2.9 kV for PC-B3).

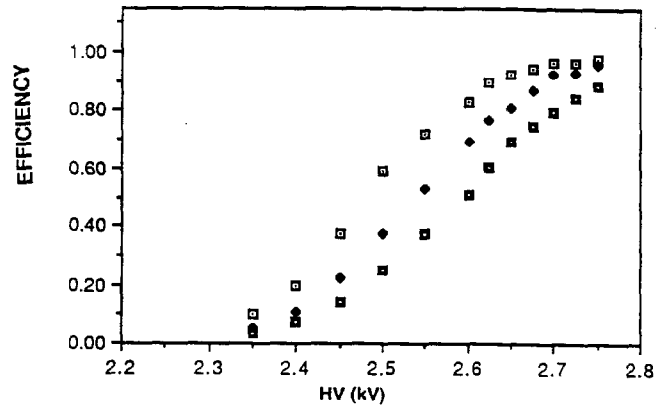
Figure 3: Plateau curves for the 1.00 mm pitch chamber (PC-B3) measured with a 300 GeV/c proton beam.

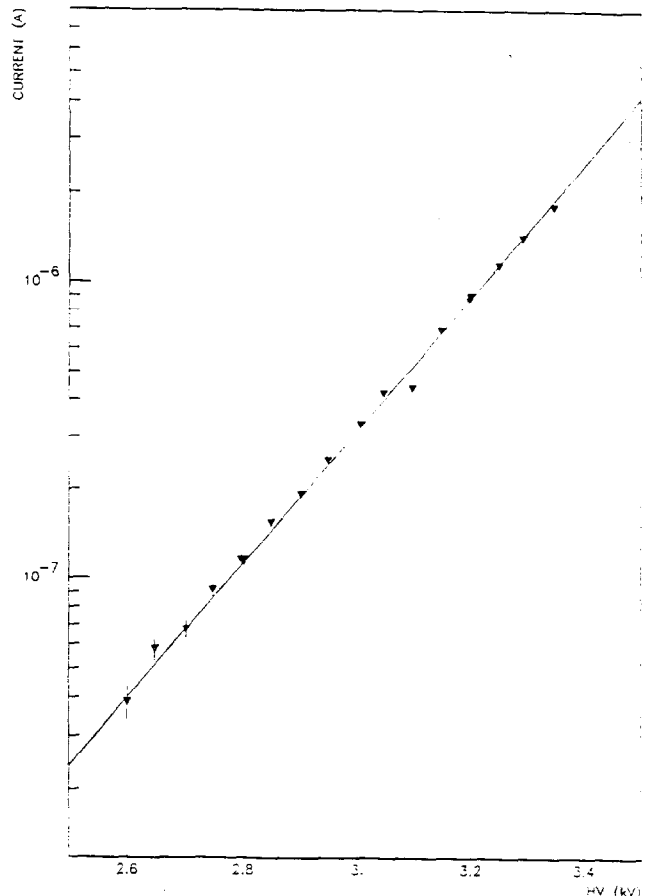
Figure 4: "Current versus voltage" characteristic of PC-B1 (U-plane), measured with a 300 GeV/c proton beam. Solid line represents the best fit to the data (details in text).

Fig. 4 shows the "current versus voltage" characteristic of PC-B1 (U-plane), measured with a 300 GeV/c proton beam. The solid line represents the best fit to the data, with the following current parameterization:

$$I(V) = e^{\alpha V + \beta}$$

where $\alpha = 5.17 \times 10^{-3} [V^{-1}]$ and $\beta = -30.50$.

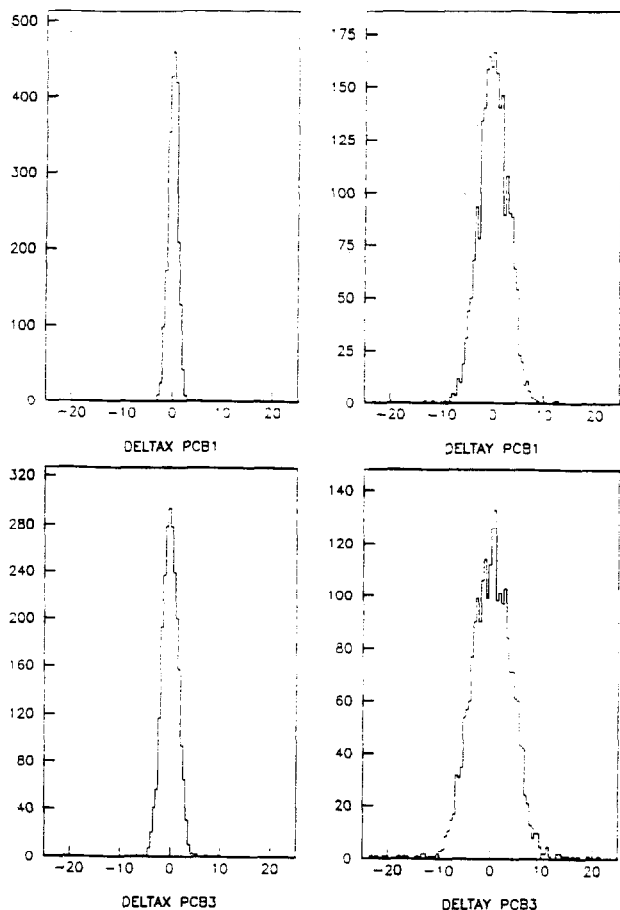
Figure 5: Residuals distributions for PC-B1 (upper part) and PC-B3 (lower part) obtained during an alignment run with a 300 GeV/c proton beam. Horizontal scale: 10 units = 1.0 mm .

$$\sigma_X = 0.15 \text{ mm}; \sigma_Y = 0.30 \text{ mm (PC-B1)}$$

$$\sigma_X = 0.17 \text{ mm}; \sigma_Y = 0.38 \text{ mm (PC-B3)}$$

The preliminary space resolution, obtained from alignment runs, is presented in Fig. 5. For the X-coordinate it is comparable to the theoretical estimate based on the following formula: $\sigma_X = \Delta / \sqrt{12}$, where Δ is the wire spacing (for PC-B1 and PC-B2 $\Delta = 0.75$ mm and for PC-B3 $\Delta = 1.00$ mm). The resolution is slightly worse for the Y-coordinate, which is determined from U and V measurements.

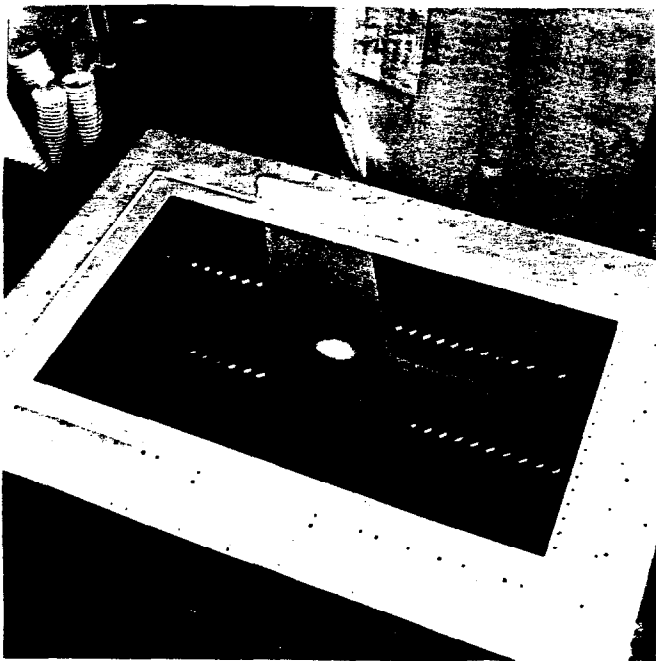
Figure 7: White deposit on aluminized kapton cathode plane occurred in the beam region after total accumulated charge of ~ 1 C/cm of sense wire.

of 0.5 % NaOH was used for etching. After removal of undesired Al coating, the kapton foils were carefully rinsed in distilled water, in weak acetic acid solution, and again in distilled water. Finally the whole cathode plane was cleaned with isopropyl alcohol. The chambers were reassembled and reintegrated into the spectrometer, where they worked satisfactorily until the end of the run, when a 10% efficiency drop was observed after a total accumulated beam flux of $\sim 10^{12}$ particles/cm². After the run, the chambers were disassembled and inspected. A white deposit with a characteristic "wire pattern" etched away from the Al coating was observed in the region of the beam spot (Fig. 7 and 8). We were unable to remove it by cleaning with acetone and alcohol. It has been argued [8] that it may be the result of aluminum oxidation, although no satisfactory explanation has been proposed as to the origin of this phenomenon.
