REVIEW OF DAMAGES OF NUCLEAR POWER PLANTS STEAM GENERATOR'S TUBES AND WAY OF DETECTING BY USING EDDY CURRENT METHOD

Author: D. Stanic, B.Sc.M.E.
INETEC - Zagreb, CROATIA

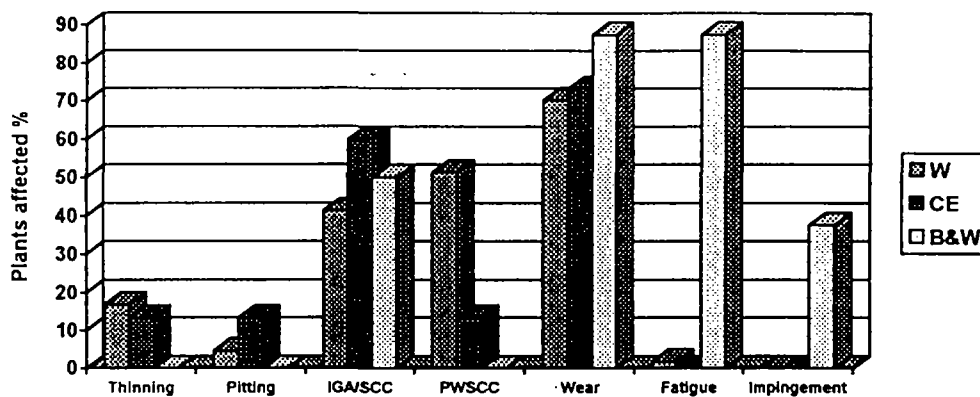
The impacts of degradation mechanisms on plants of various NSSS vendors are presented in Figure 2.

Figure 2. Tube degradation in PWR steam generators

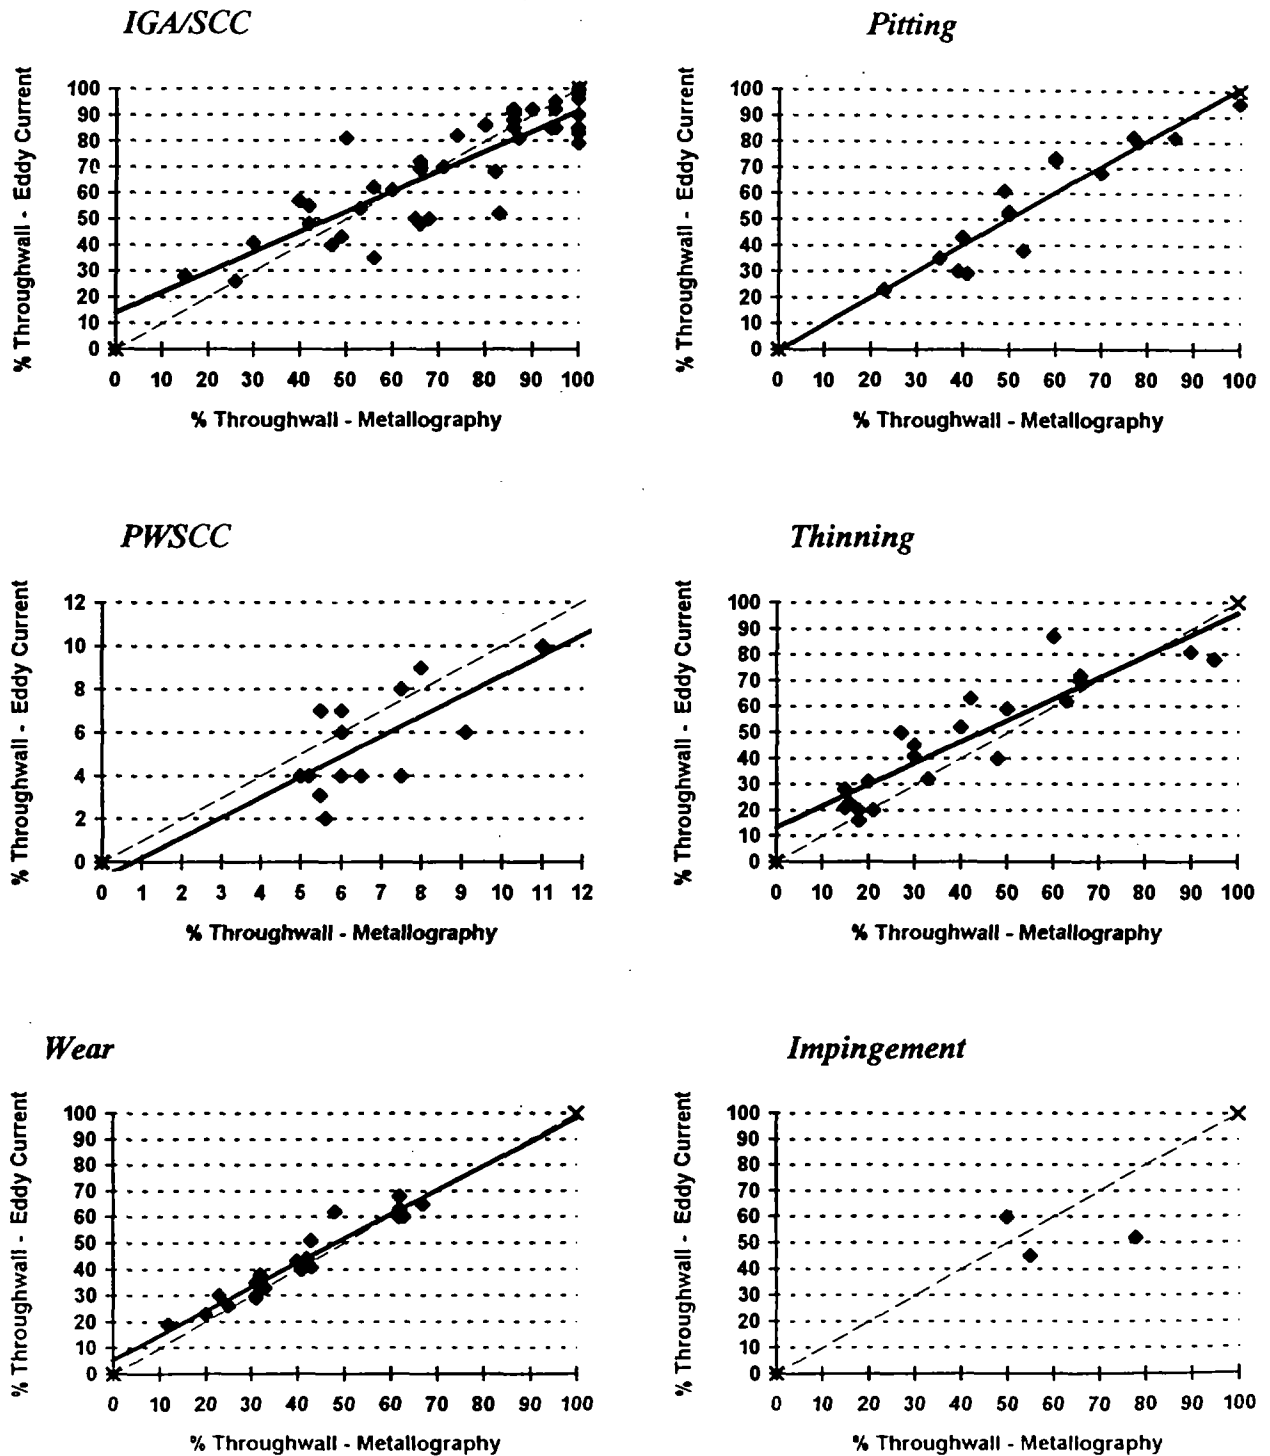
often unknown, are almost impossible to replicate exactly under laboratory conditions. Since eddy current data used for correlation was acquired prior the tube removal, the detrimental effects of tube distortion caused by tube removal forces are also eliminated. In the case of significant discrepancy between eddy current data results and metallography results, reanalysis was done in order to define appropriate data analysis procedure. A scatter plot of eddy current measurements versus actual depth for different degradation mechanisms are shown on Fig. 4.

Figure 4 Eddy current accuracy for different degradation mechanisms
