IRRADIATION TESTS OF READOUT CHAIN COMPONENTS OF THE ATLAS LIQUID ARGON CALORIMETERS

Various readout chain components of the ATLAS liquid argon calorimeters have been exposed to high neutron fluences and γ doses at the irradiation test facility of the IBR-2 reactor of JINR, Dubna. Results of the capacitance and impedance measurements of coaxial cables are presented. Results of peeling tests of PC board samples (kapton and copper strips) as a measure of the bonding agent irradiation hardness are also reported.

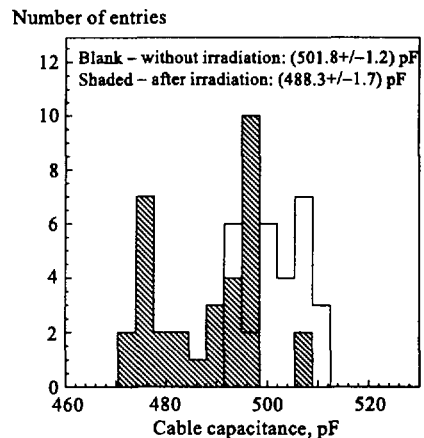
The results for two groups of cables are presented in Fig. 1. The histogram shows the capacitance values of the nonirradiated group of cables of reference (blank area) and of the group of cables irradiated to the fluence $1.8 \cdot 10^{16} \text{ cm}^{-2}$ (shaded area).

The distribution of the irradiated cables capacitance values became wider and was shifted to lower values by ~ 13 pF when compared with the reference group data. The capacitance

Fig. 1. Cable capacitance measured for the group of cables irradiated to the fluence $1.8 \cdot 10^{16} \text{ cm}^{-2}$ (shaded area) and for the nonirradiated group of reference (blank area)

averaged over each group is (501.8 ± 1.2) pF and (488.3 ± 1.7) pF for the nonirradiated reference group and irradiated cables, respectively.

Thus, a 2% degradation of the kapton cable capacitance is observed after irradiation of the cables to a high neutron fluence and γ dose.

Peeling tests of copper strips laminated to PC boards revealed a 6% decrease of the peeling load after exposure to a neutron fluence of $7 \cdot 10^{15}$ cm⁻² and a γ dose of 67 kGy. Also, a 2% degradation of the kapton coaxial cable capacitance was found after cable exposure to a high neutron fluence of $1.8 \cdot 10^{16}$ cm⁻² and an accompanying γ dose of 300 kGy.

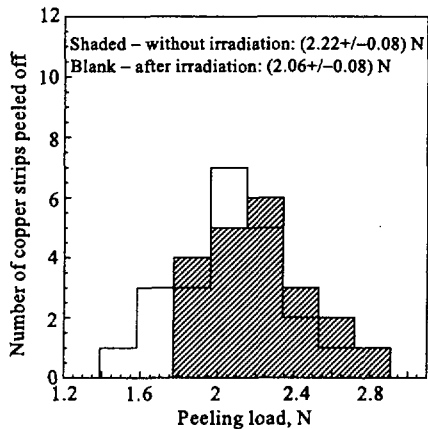
Fig. 2. Peeling load measured for the group of PC boards exposed to high neutron fluence (blank area) and for the reference group (shaded area)

The results of the measurements for the two groups of samples are shown in Fig. 2. The averaged values of the peeling load are (2.06 ± 0.08) N and (2.22 ± 0.08) N for the irradiated and reference samples, respectively. Thus, a 6% degradation of the bonding agent hardness have been observed. Nevertheless, the value of the peeling load after $7 \cdot 10^{15}$ cm⁻² of neutron fluence and 67 kGy of γ dose is quite acceptable for application in the ATLAS FCAL.

Two groups of samples were subjected to the peeling tests, after the run. In accordance to the Standard Tests Methods (*Designation D 5109-94*) the load was applied to the copper strip in the vertical plane and a constant reading of the needle indicator was recorded (at a peeling speed of 40 mm/min).

The major bulk of measurements was carried out at a peeling speed of 40 mm/min. Figure 3 shows the peeling load dependence on the value of the peeling speed. The *Designation D 5109-94* requires a speed value of 50 mm/min. So a 5% correction factor has to be applied, approximately, to the peeling load shown in Fig. 2.

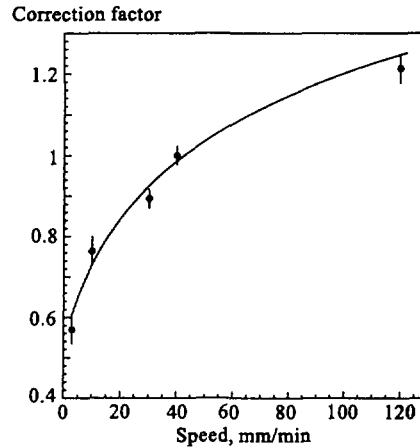
Fig. 3. Peeling load dependence on the value of peeling speed. Load is normalized to unity at a speed value of 40 mm/min
