Termination of Past Nuclear Activities at the Nuclear Research Institute

Helena Janžekovič, Milko Križman
Slovenian Nuclear Safety Administration
Železna cesta 16, SI-1001 Ljubljana, Slovenia
helena.janzekovic@gov.si, milko.krizman@gov.si

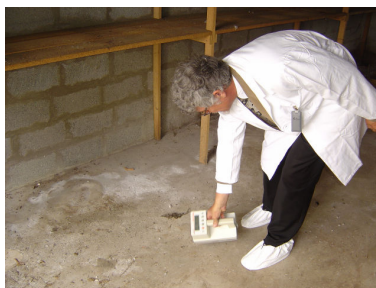
On the on – site inspection as a rule an inspector was accompanied by the expert of the SNSA. The essential part of the on – site inspections was a use of the measurement equipment in order to find the contaminated areas or sources of ionising radiation. The instrument *FieldSpec* [4] for measurement of gamma dose rate and identification of radionuclides emitting gamma with ^3He counter for a detection of neutrons was used. In addition a contamination monitor was used when necessary. Also a personal electronic pager for a fast detection of the gamma radiation was used. The contamination areas were scanned by a Berthold *Contamination Monitor LB 122*. Figure 1 shows the expert from the SNSA on the on site – inspection at the IJS measuring the contamination of the floor of an abandoned storage.

Figure 1: Measurement of the floor contamination on the on site inspection of the SNSA at the IJS.

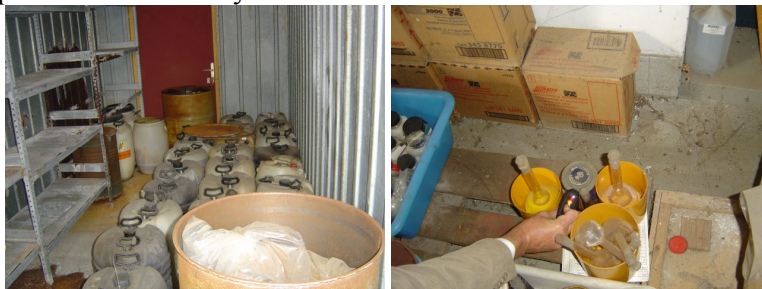
- In addition during the inspections of SNSA around 200 unregistered sources or out of a proper control were found at the IJS. During handling of some sources only part of protective measures was in place. Furthermore, some sources were not treated as radioactive material at all either during their storage or during their everyday use. Some sources were liquids which required pre-treatment before their storage in the Central Interim Storage for Radioactive Waste. Figure 2 shows abandoned storages of the liquid radioactive waste with uranium compound as well with yellow cake at the IJS.

Figure 2: Abandoned storages of the liquid radioactive waste with uranium compound as well with yellow cake at the IJS.

The IJS immediately started with the remediation activities including the decontamination of two nuclear laboratories and three different storages of radioactive waste at its sites. Meanwhile 60 above mentioned sources have been already stored in the Central Interim Storage for Radioactive Waste. The IJS staff started with decontamination procedures at some areas and the pre-treatment of radioactive liquids. The decontamination procedures are still in progress. Figure 3 shows the decontamination of contaminated oven which was used in the past in the research of uranium compound at the IJS.

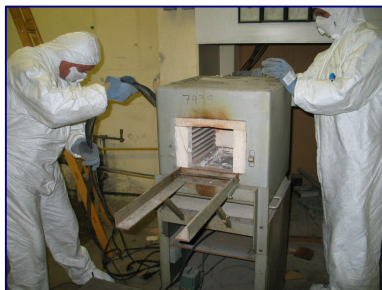
Figure 3: Decontamination of contaminated oven which was used in the past in the research of uranium compound at the IJS. The picture was provided by the IJS.
