Improving of spent fuel monitoring in condition of Slovak wet interim spent fuel storage facility

Abstract

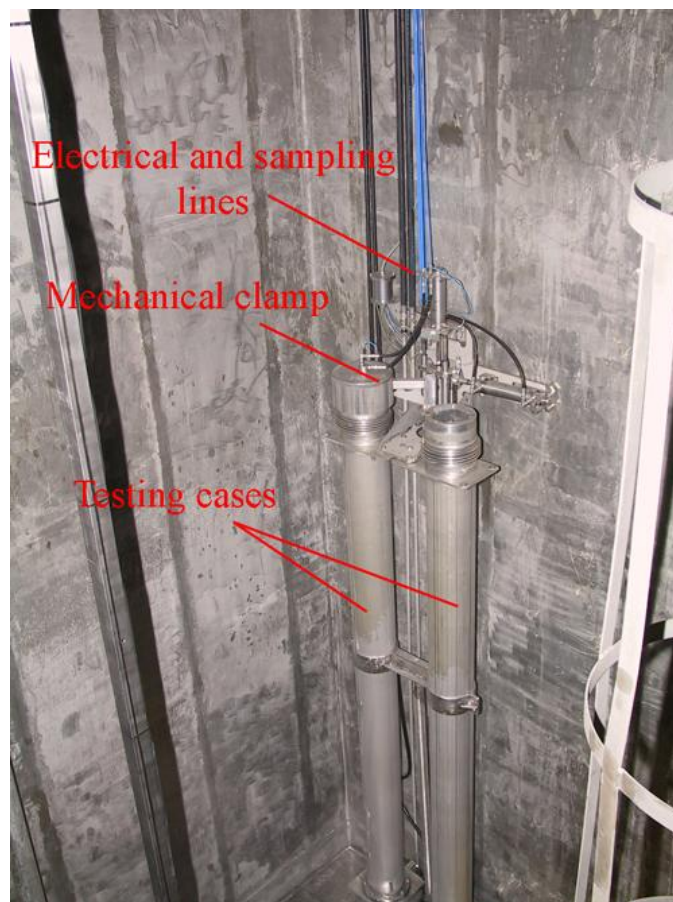
Fig.1 Sipping in Pool

First system “Sipping in pool” (Fig.1) was designed by Framatome-anp for monitoring of the spent fuel from VVER-440 reactors. It was build and implemented to the special small pool at storage facility in 1999 and practice showed great results during measuring. This system contain from 4 main parts:

- 2 electrical heated cylindrical caskets,
- mechanical clamp,
- electrical and sampling lines,
- controlling and bleeding panel.

The fuel assembly is inserting into the special case which is electrical heated by three electrical heaters (5kW). After closing of the upper end of the case by the clamp, the temperature inside increase. If there are any leakages, they start to open themselves due to thermal expansion and the fission product escapes out from the element. Also because of increasing the temperature the pressure inside assembly increase too, so the fission products are treading out through even small leakages. Then, the liquid sample from the case is taken and evaluated. The sample is analyzed by gamma spectroscopy (Table1). If this test proves that there are any leakages on the fuel element cladding, the defected fuel assembly is closed into a special hermetic container (T-13).

The detection ability of leakages in fuel cladding by the “Sipping in pool” system is excellent, but it will take too much time. Although, testing of one fuel assembly takes of about 30 minutes only, there is not any possibility how to identify were the leaking fuel assembly is

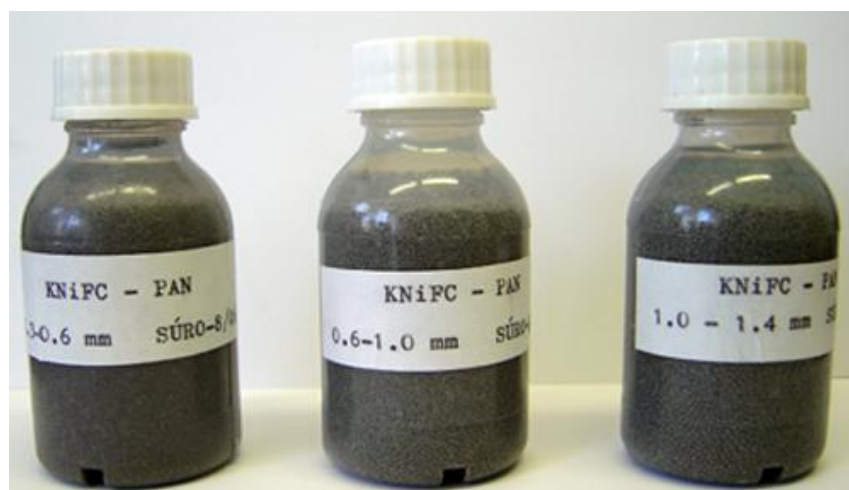
Fig.3 Different size of KNiFC-PAN sorbent

First type of sorbent was KNiFC-PAN (Potassium-nickel hexacyanoferrate incorporated in polyacrylonitrile organic matrix) [7], with three type of diameter: 0,3-0,6mm, 0,6-1,0mm and 1,0-1,4mm (A, B, C, Fig.3).

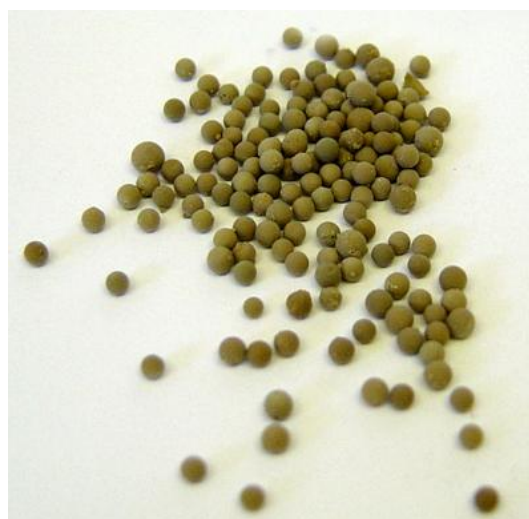
Fig.4 Nifsil

Second type of sorbent was Nifsil (composite sorbent based on potassium nickel ferrocyanide incorporated in silica gel (inorganic) matrix) with diameter 0,5-1,0mm (D, Fig4) [8].

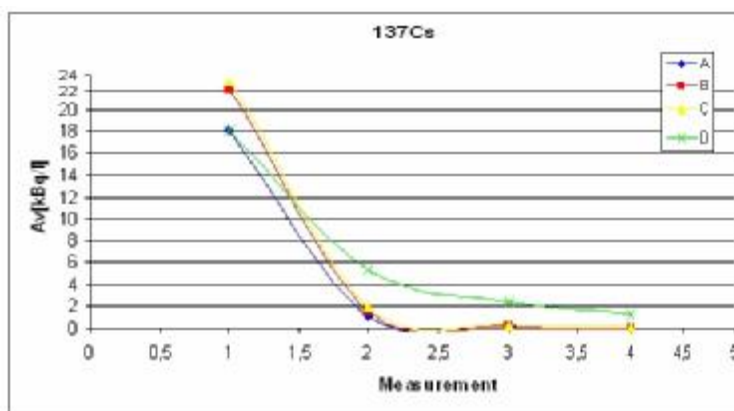
Fig.5 Decreasing of volume activity [kBq/l] of ^{137}Cs due to sorbent sorption

Water sample from spent fuel pool at NPP in Jaslovské Bohunice was used. Five gamma-spectroscopic measurements were made:

1. Water sample without any sorbent,
2. Water sample with different sorbents, measured after 1 day,
3. Water samples with different sorbents, measured after next 3 days,
4. Water samples with different sorbents, measured after next 3 days,
5. Water samples with different sorbents, measured after next 4 days.

From the measurements is clear, that sorbent KNiFC-PAN has better sorption properties for cesium than Nifsil.
